SHERINGHAM POINT LIGHTHOUSE

RESTORATION
2015 - 2019

Final Report
&
Documentation

Sheringham Point Lighthouse
Preservation Society

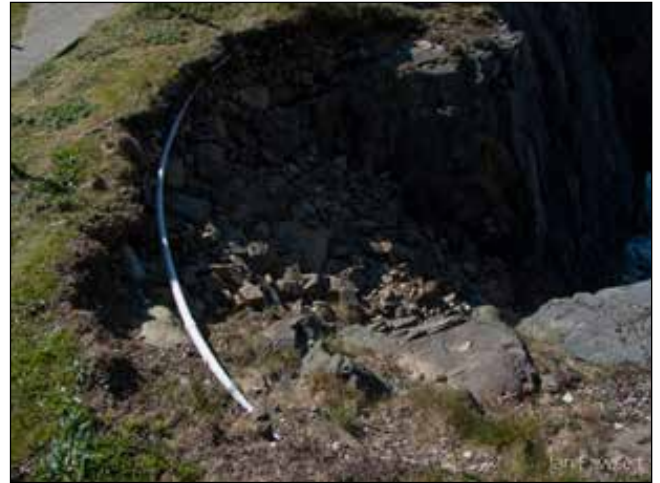
Image 3 (top left): erosion on the east side of the causeway

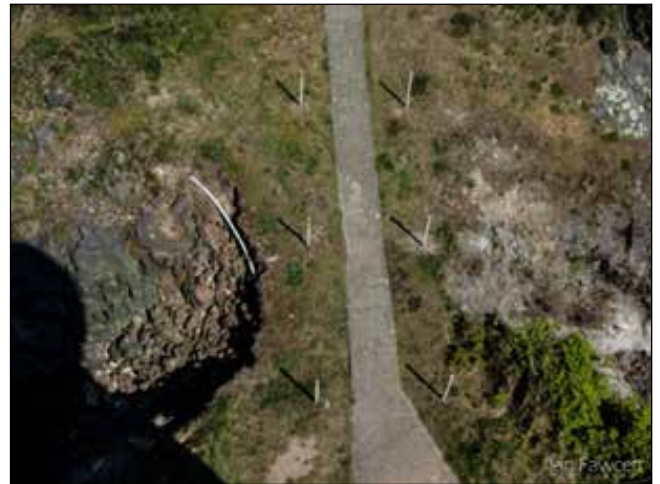
Image 4 (top right): erosion on the west side of the causeway

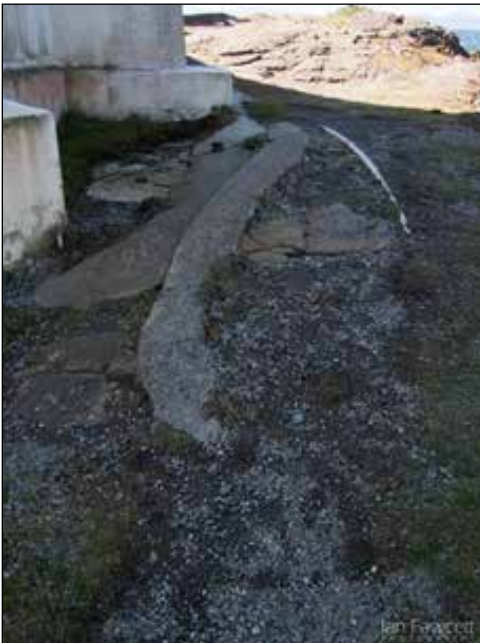
Image 24 (left): previous above-ground asphalt covering - not to code

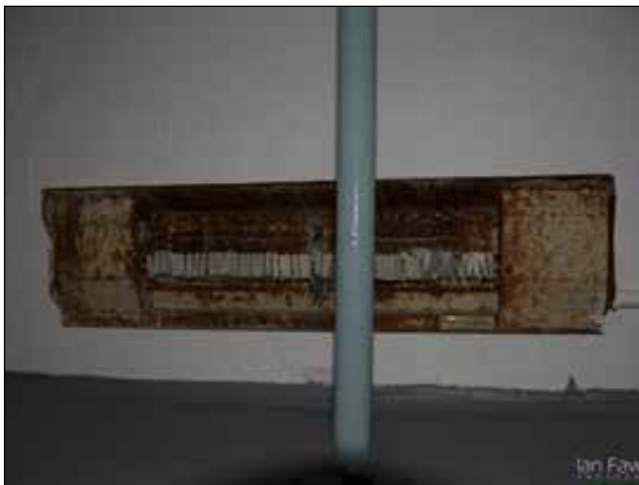
The basic electrical fixtures in both the engine room and tower were corroded beyond usability and were replaced. This included overhead lighting (fluorescent) and baseboard heaters in the engine room, and wall -lights and baseboard heaters in the tower. Efforts to find exact replicas of these fixtures in reasonable working order were unsuccessful, so near-approximations were used. In addition protective steel cages were installed over the bare lightbulbs in the tower to ensure user safety. (See following photographs).

Image 35 (top left): previous, corroded baseboard heater in tower

Image 35 (top right): Replacement baseboard heater in tower

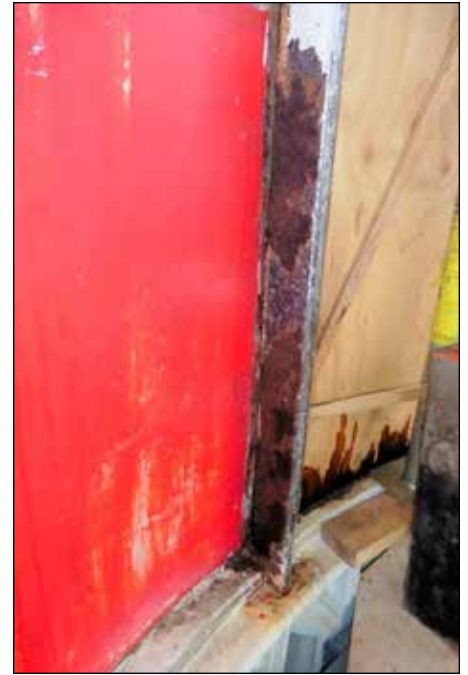
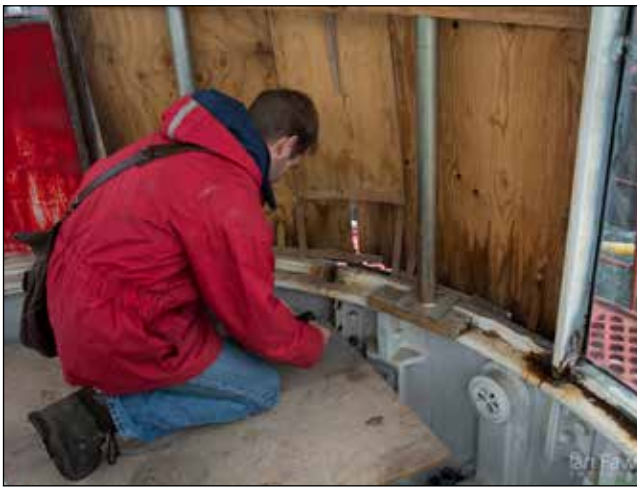
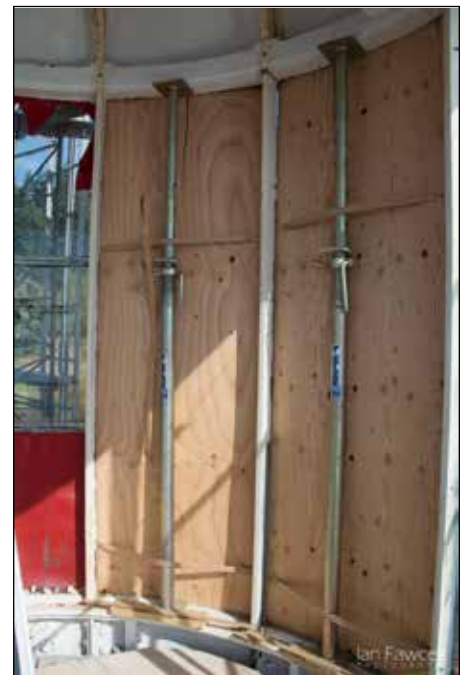
The removed mullion was taken to Smith Bros. Foundry and Machine Works, where it was cleaned to permit examination by John Dam. Fortunately the corrosion was found to be limited to the exterior of the mullion, and its structural integrity was sound. This meant that the remaining mullions (which were not as badly corroded as the test one) could be left in place, and just surface cleaned. This also meant that the strategy for restoration and, in particular, the window replacement, would be significantly simpler (and cheaper) in that no shoring would be required and all windows could be replaced at once. The removed mullion was later re-installed by welding it back together on site, with a small extension (about ½ inch) added to replace the material that had been cut away. (See following photographs).

Image 39, 40 and 41 (top row): corrosion on lantern room mullions, prior to treatment

Image 42 (bottom left): Engineer John Dam assessing extent of corrosion on lantern room posts and base mounting ring

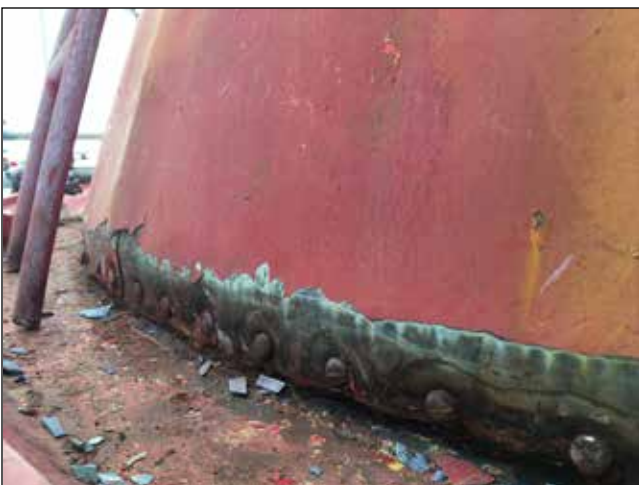
Image 51 (bottom): gutter of dome showing extensive corrosion, also around rivets which is a likely source of water leakage into the lantern room

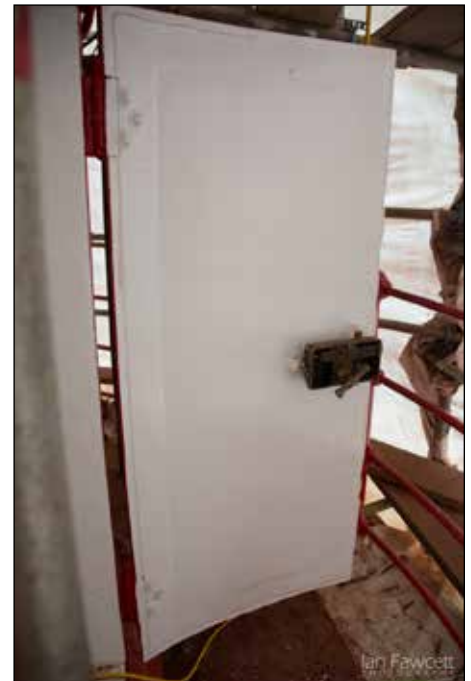
The exterior door leading from the lantern room to the exterior walkway was severely corroded, on both the interior and exterior sides. Blacksmith Marty Gilbertson (Foggy Mountain Forge) was consulted about how best it could be restored and it was recommended that the interior cast steel panel be removed and replaced, as it was too corroded to be repaired. It was felt that the exterior could be cleaned and restored.

Image 65 (left): lantern room door interior, showing corrosion and beginning of separation of top panel from the rest of the door

Image 66 (centre): lantern room door exterior, showing extensive corrosion

The door was removed from its hinges and taken to Foggy Mountain Forge, where the work was completed (except the painting). The restored door was rehung in the lantern room, but it was found not to close properly, due to the rigidity of the new plate that had been attached. This required that it be removed again, returned to the forge where it could be slightly bent, and then rehung. It now fit relatively well, and it was decided to install some weather stripping around the edges to provide a better seal. The door was then painted along with the rest of the lantern room. (See following photographs).

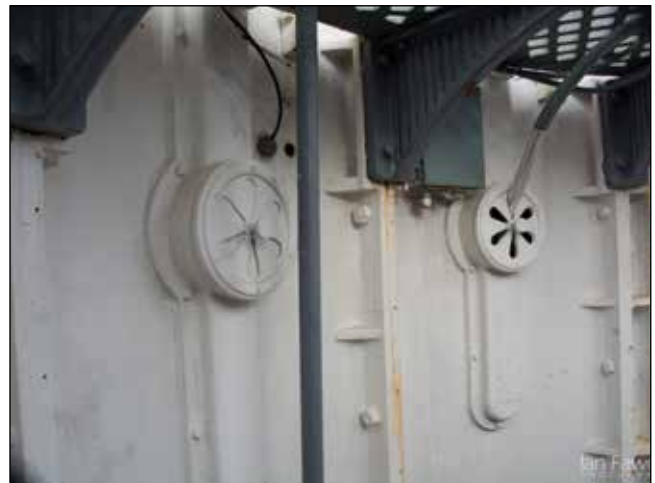
Image 74 and 75 (top row): original condition of lantern room interior, showing some corrosion

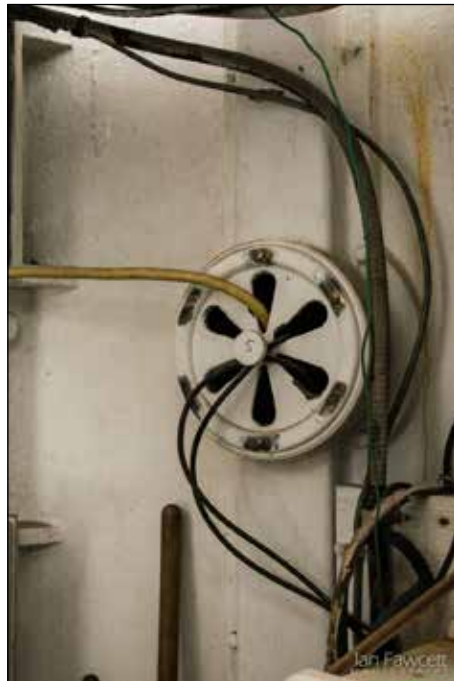
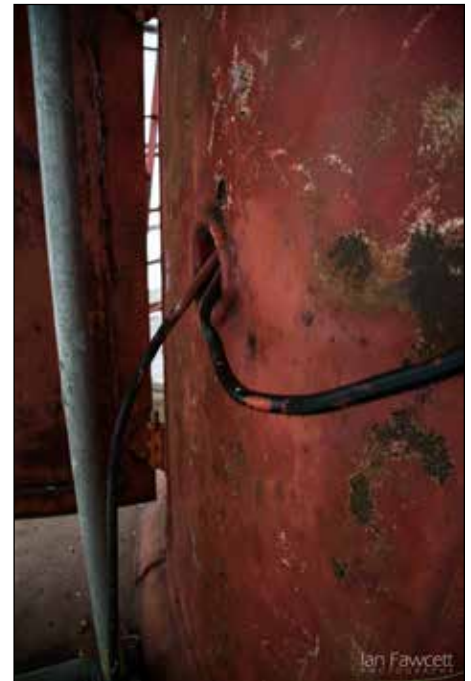
The main challenge was that the cables feeding the exterior equipment had been fed casually through the vents, rendering them non-functional. As the vents were being restored, an alternate route for these cables was necessary. An option was considered of routing the cables through a more-recently-added aluminum frame window, rather than cutting into the historic fabric of the lantern room itself, however, after consultation with an electrician, it was determined that this option would not be possible (to provide a secure exit) without further damage to the lantern room wall. Accordingly it was decided to re-route these cables through a small hole drilled adjacent to one of the vents to provide proper, sealed and permanent access to the exterior (the same as had been done previously for other cables). (See following photographs).

Images 81, 82 and 83: previous arrangement of cables in lantern room, going through vents to the exterior, and loose cables exiting vent on the outside

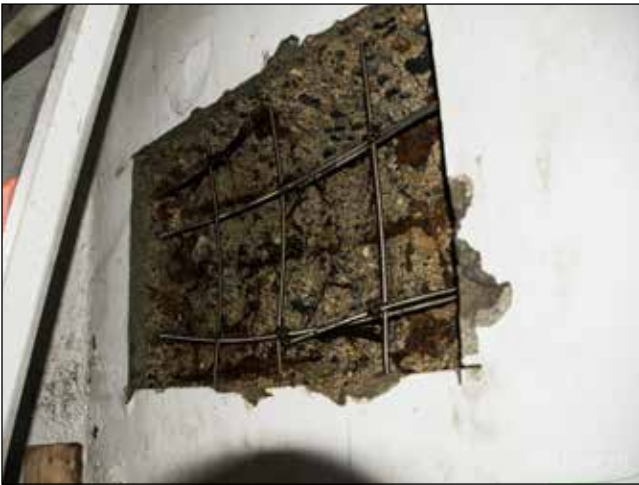
Among the first steps taken was an inch-by-inch examination of the entire interior of the tower walls, to identify every weak spot and mark it for repair. It was decided that repairs would be done by using hand-held equipment to chip away and deteriorated concrete. This was the safest and most “heritage-sensitive” approach, removing as much deteriorated material as necessary, but as little as possible. The exposed areas were then refilled with a pre-mixed, polymerized cement mortar compound (Planitop-X). In larger exposed, the mortar was reinforced with a re-bar grid. (See following photographs).

Images 86(top left) and 87 (centre left): show repair target areas chipped out with stainless steel reinforcing bar (grid) inserted

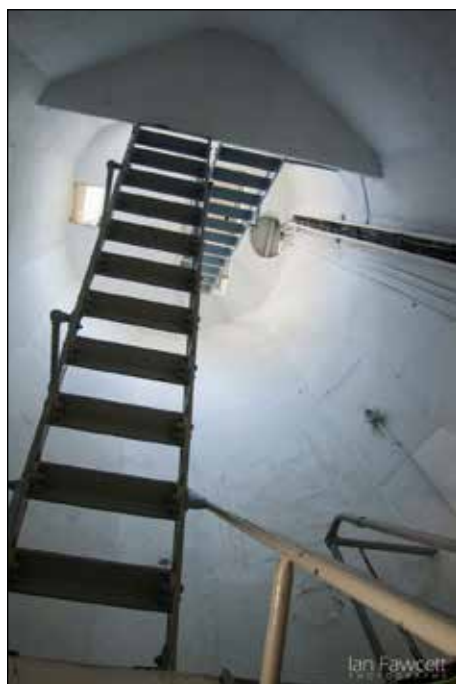
Images 92 and 93 (top row): showing stained and flaking condition of paint in tower interior

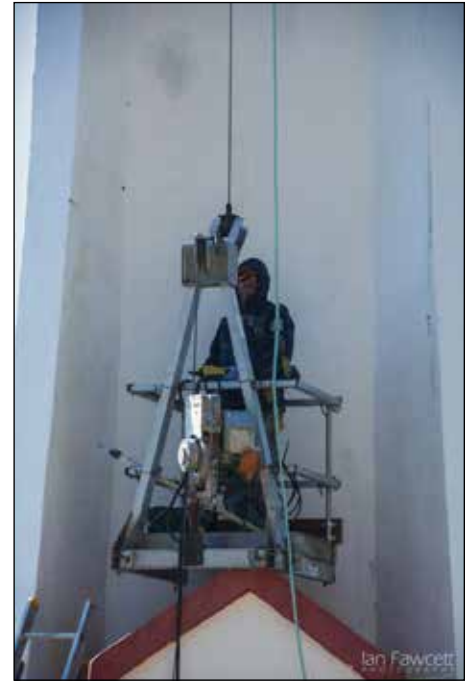
Image 102 (top left): pre-painting condition, showing staining at top, along buttresses and around base

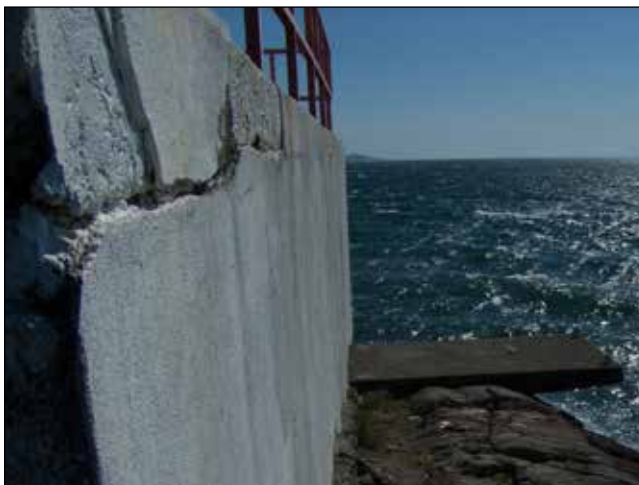
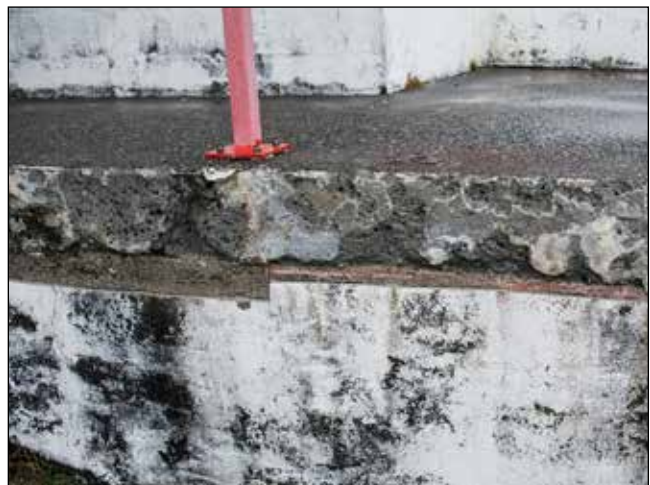
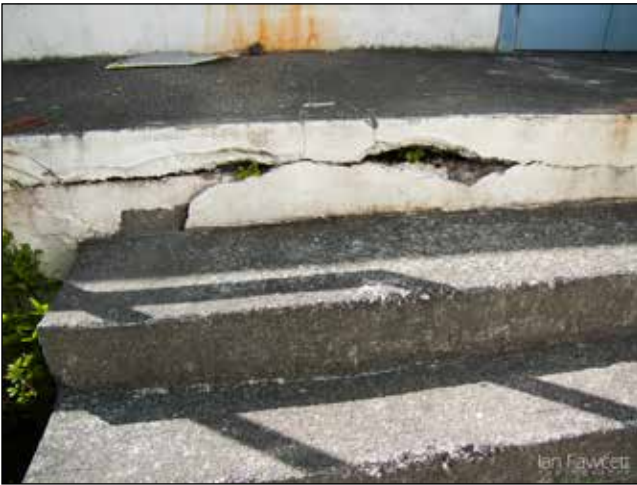
Images 108, 109 (previous page and 110 (top left): showing cracking and crumbling in concrete base and stairs of engine room

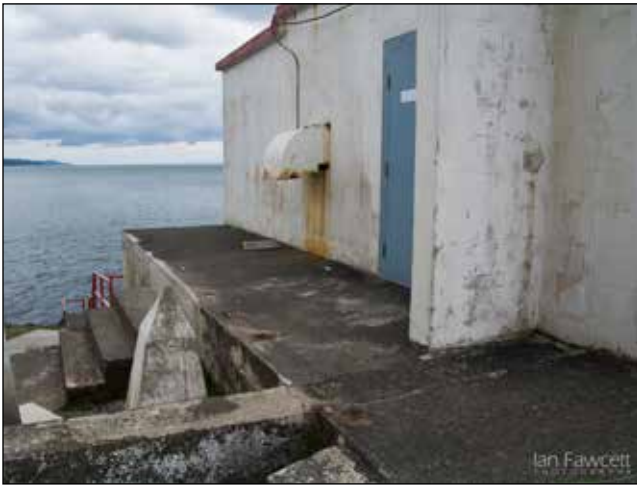
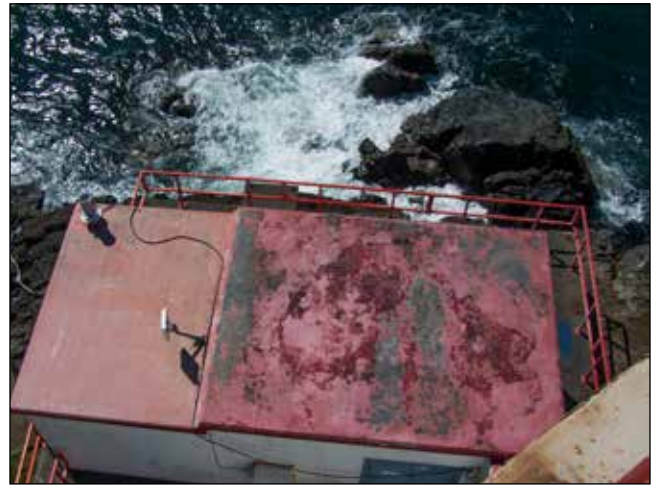
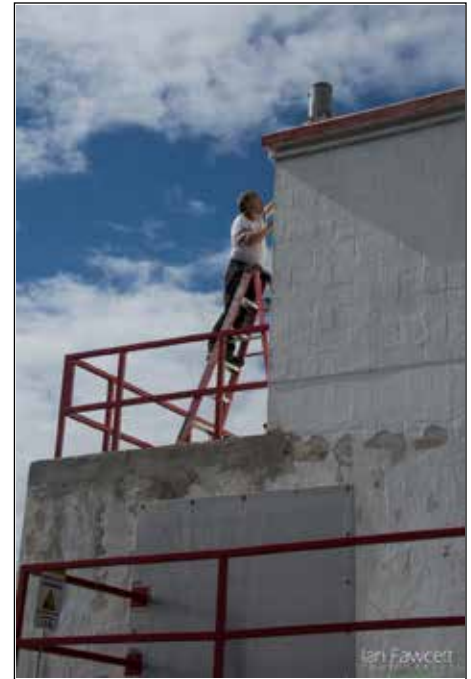
Note: since the painting was completed, a small water leak from the roof has been detected. The point of ingress is where a dish transmitter (installed by the Department of Fisheries and Oceans for it whale monitoring program) is attached to the roof. The point of attachment will be caulked until such time as the transmitter is removed (connection will be via the Society's communications cable), at which point the area will be sealed. (See following photographs).

Images 114, 115 (top row) and 116 (centre left): show paint condition on walls, roof and base

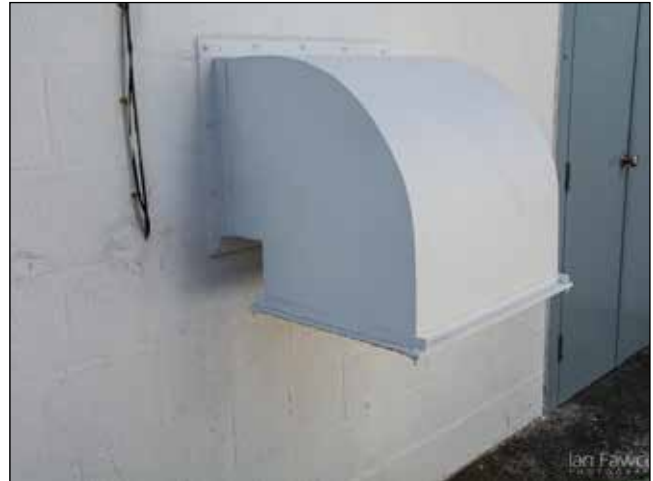
An air vent hood attached to the north wall of the engine room was seriously corroded, with parts of it completely eaten away. Also the metal brackets that attach it to the wall opening were seriously corroded, beyond repair. The vent hood was removed and taken to Foggy Mountain Forge, where a replica hood and mounting brackets were manufactured. The hood new hood was installed, and then painted. (See following photographs).

Images 120 (left): vent hood showing extensive corrosion damage

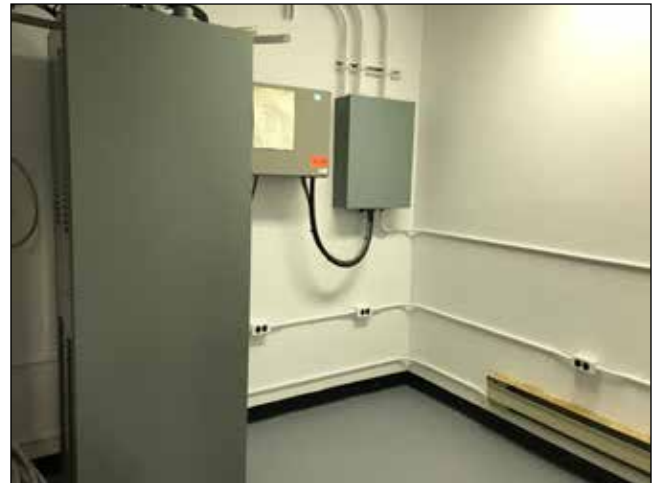
Images 122 (top left) and 123 (bottom left):: showing condition of interior walls and floor - note mould in corner and wrinkling along bottom

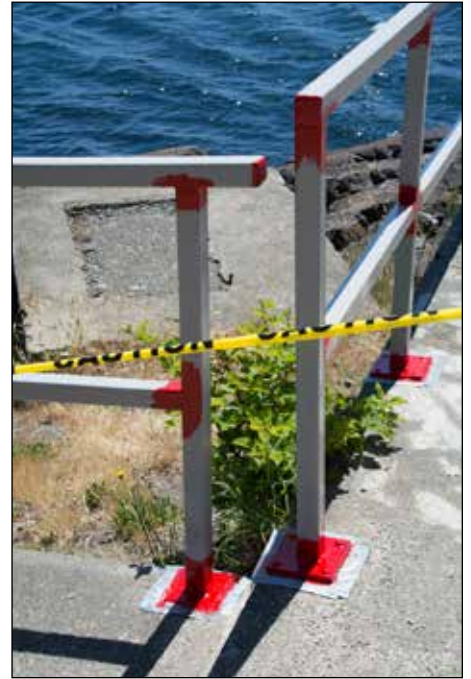
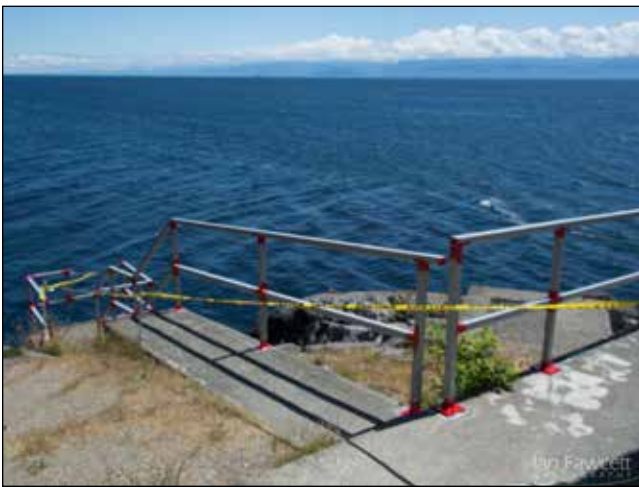
Images 131 and 132 (top left and centre): condition of remaining rails
