SHERINGHAM POINT LIGHTHOUSE

RESTORATION
2015 - 2019

Final Report
&
Documentation

Sheringham Point Lighthouse
Preservation Society

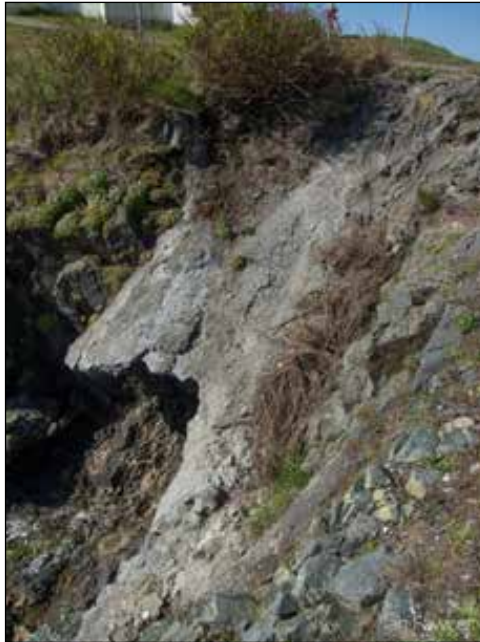
Image 3 (top left): erosion on the east side of the causeway

On the west side, a backhoe was used to place large boulders, individually in a stacked wall adjacent to the inside wall of the gulley. The stacked wall tilts slightly inward to ensure the greatest stability.

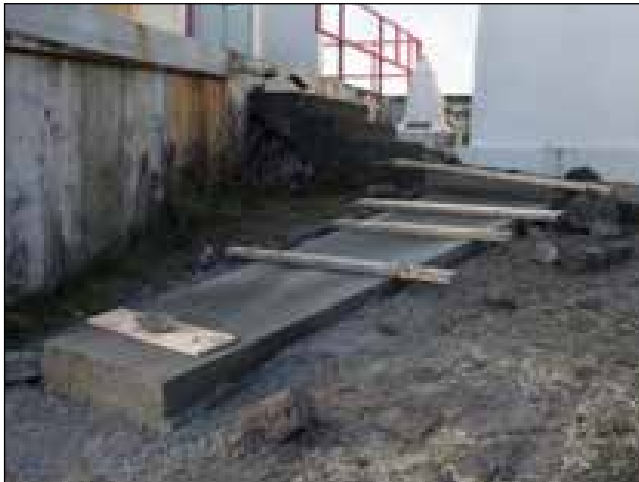
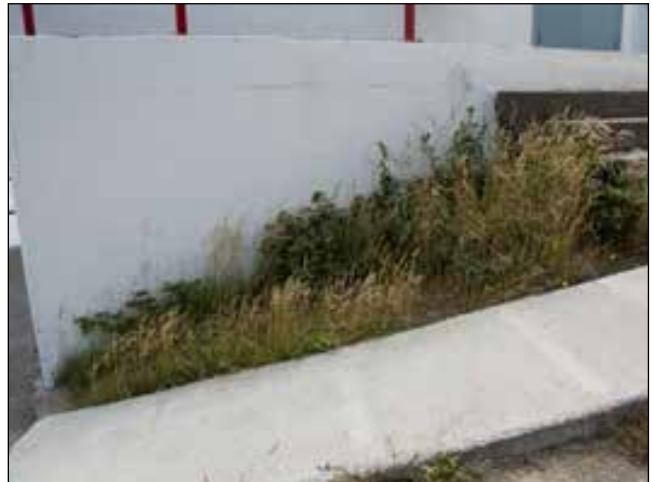
Image 8 & 9 (above): new pathway under construction & completed

Previously, there was no defined pathway connecting the existing concrete pathway that led around the east side of the tower to the concrete pathway along the eastern side of the engine room (and leading down the stairs to the lookout). This area was just bedrock, and was uneven. As it was one of the areas most heavily used by visitors, it was a serious tripping hazard. A decision was made to build a new concrete pathway to connect the two existing pathways. As Clarkston Construction was on site with a cement mixer (for the retaining wall), they were asked to also install the pathway. This now provides a safer walkway all around the heritage structures. (See following photographs).

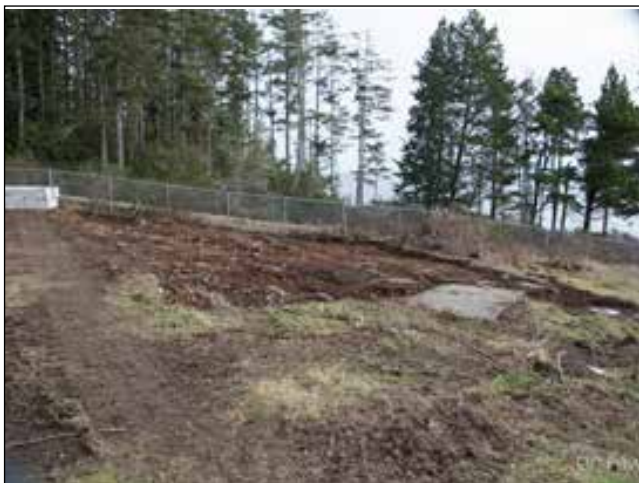
Image 12 (above left): cleared site for installation of solar array

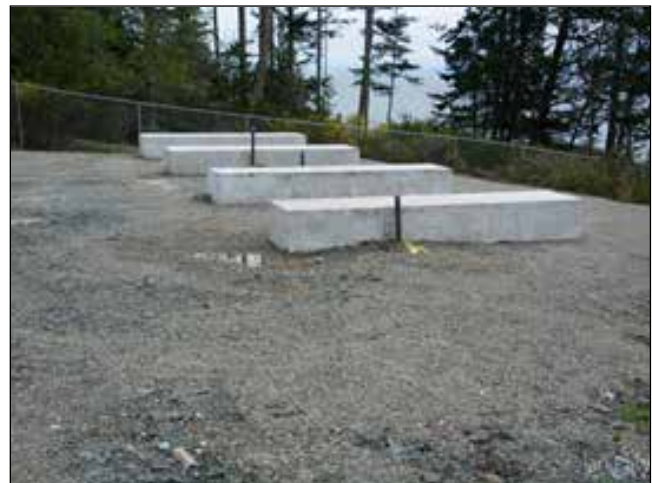
Image 13 (above right): array site filled, compacted and levelled with concrete ballasts installed

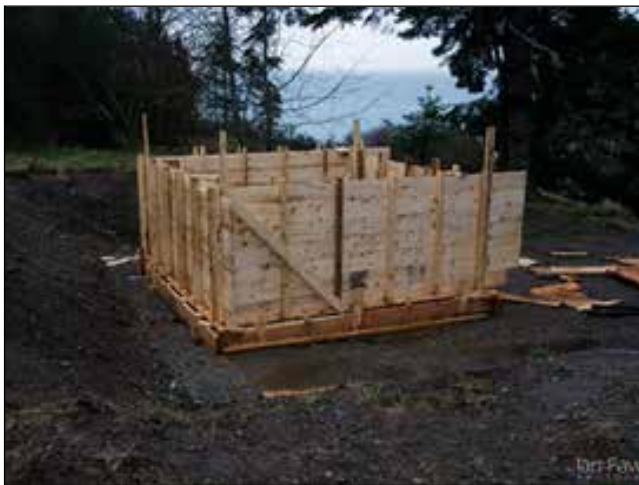
In preparing the site for the building, an error was made in the excavation, which was deeper than originally anticipated. As a result, it was decided to place the shed on a foundation, rather than a concrete pad, in order to bring it back up to grade. The building itself was a frame construction, approximately 10' x 10' in diameter, with a peaked roof. It was vented at each gable end and the entrance door located in the west wall. Hardy plank siding was used to finish the exterior and a sheet metal roof installed. Final painting of the shed (interior and exterior) was done by Society volunteers. (See following photographs).

Image 17 (top left): excavation and foundation forms

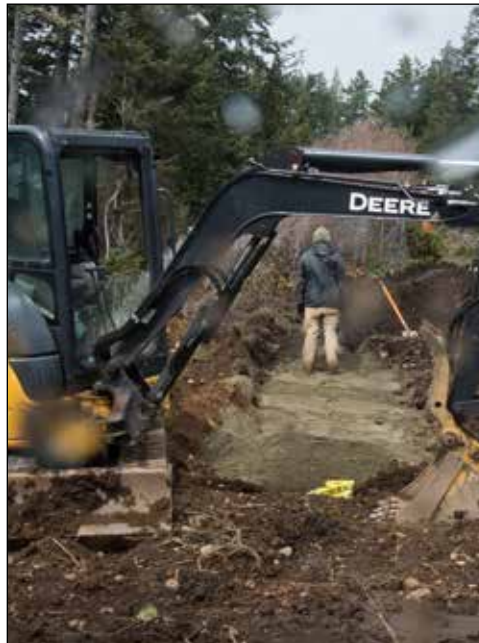
Image 25 (centre): digging the trench along the causeway

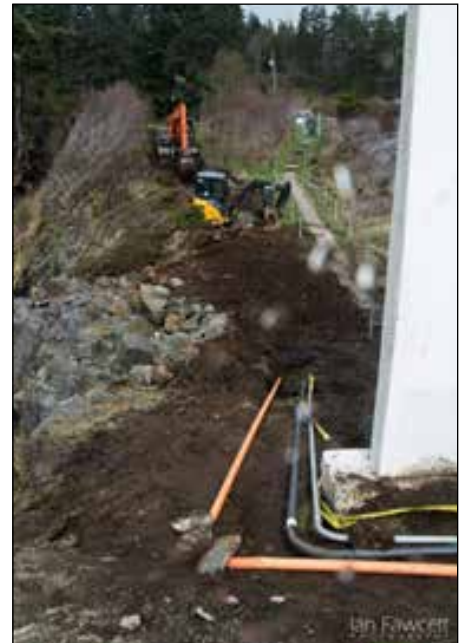
Image 26 (right): power and communications conduits extending above the bedrock at base of tower

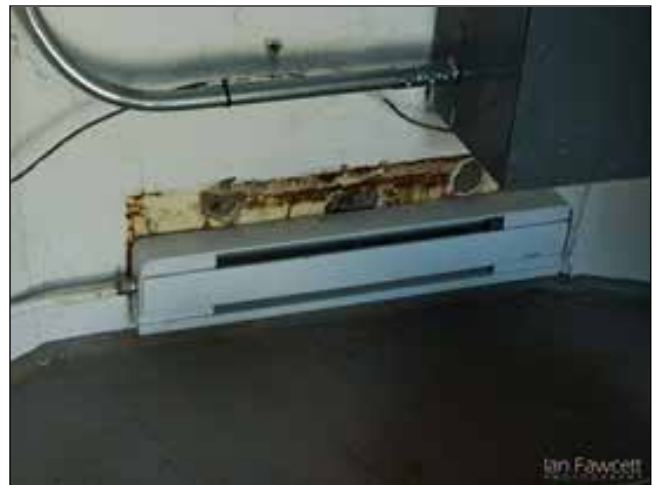
Image 35 (top right): Replacement baseboard heater in tower

The basic electrical fixtures in both the engine room and tower were corroded beyond usability and were replaced. This included overhead lighting (fluorescent) and baseboard heaters in the engine room, and wall -lights and baseboard heaters in the tower. Efforts to find exact replicas of these fixtures in reasonable working order were unsuccessful, so near-approximations were used. In addition protective steel cages were installed over the bare lightbulbs in the tower to ensure user safety. (See following photographs).

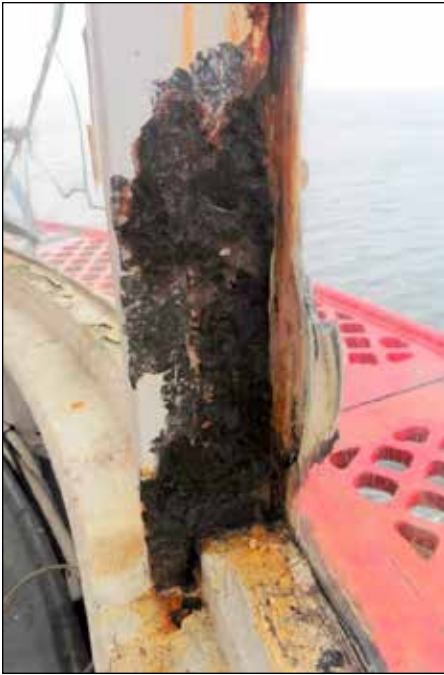
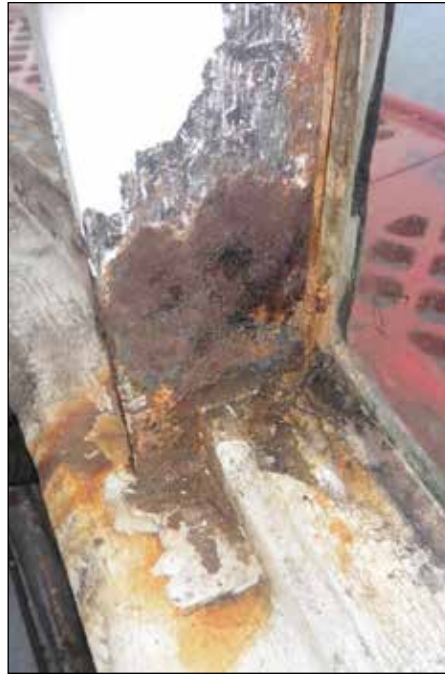
The removed mullion was taken to Smith Bros. Foundry and Machine Works, where it was cleaned to permit examination by John Dam. Fortunately the corrosion was found to be limited to the exterior of the mullion, and its structural integrity was sound. This meant that the remaining mullions (which were not as badly corroded as the test one) could be left in place, and just surface cleaned. This also meant that the strategy for restoration and, in particular, the window replacement, would be significantly simpler (and cheaper) in that no shoring would be required and all windows could be replaced at once. The removed mullion was later re-installed by welding it back together on site, with a small extension (about ½ inch) added to replace the material that had been cut away. (See following photographs).

Image 39, 40 and 41 (top row): corrosion on lantern room mullions, prior to treatment

John Dam & Associates were consulted as to how to extricate one of the mullions without damaging the surrounding structure, as well as how to re-install the original (or replacement) mullion without having to cut into the surround structure. As it was secured in place, and could not be removed without cutting either the mullion itself or either the wall or roof structure to which it was attached, it was decided to cut the mullion on site in order to remove it. This required prior removal of six window panes (one column on either side of the mullion) and installation of two screw jacks to support the roof. The gap in the windows was also boarded up.

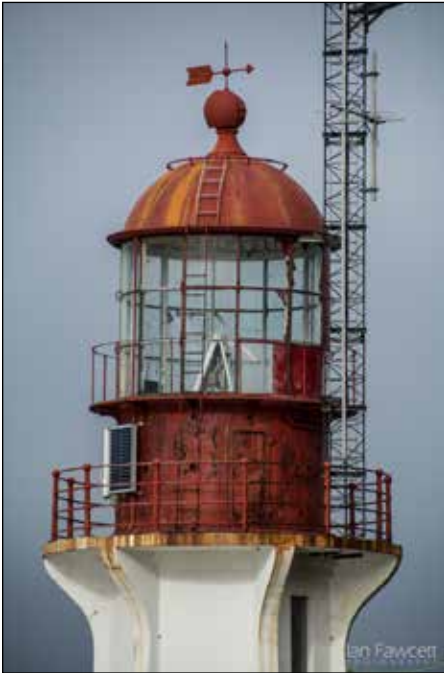
Image 47 (top left): lantern room exterior showing extent of corrosion on walls and roof

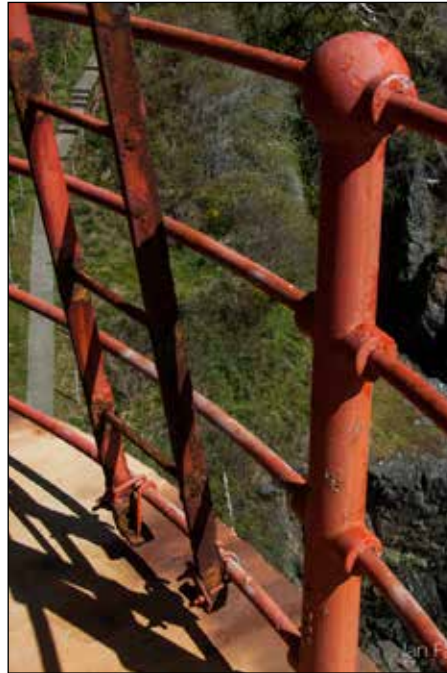
Image 48 (top centre): rails and ladder showing corrosion - extensive in some localized spots (e.g. bottom of ladder)

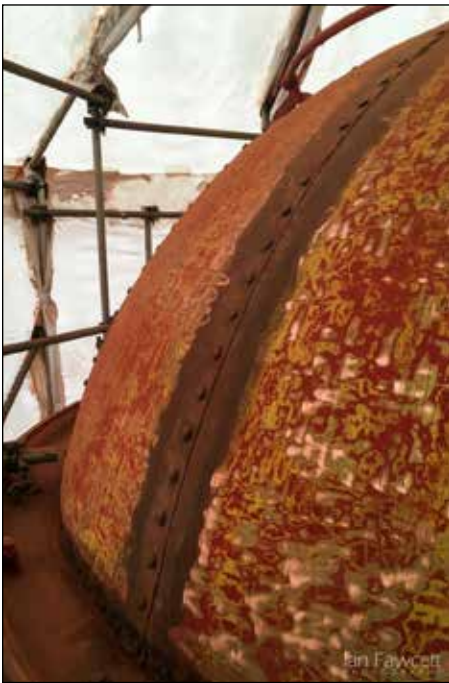
Image 52 (top left): dome exterior, in progress, with surface corrosion removed and prepped for painting - showing it is made of copper

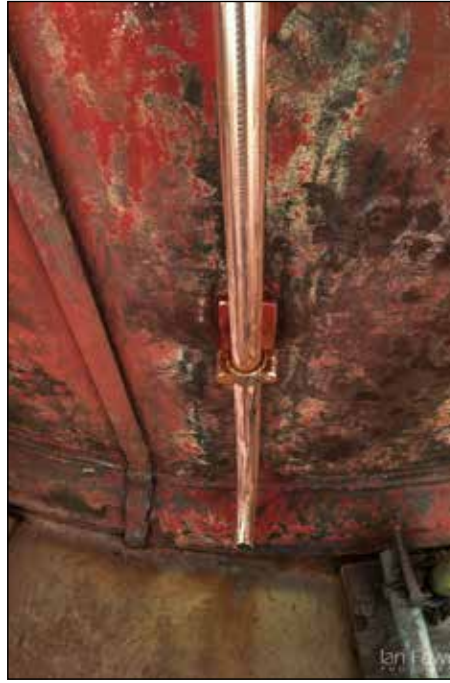
Image 53 (top centre): downspout cleaned and prepped - showing it is made of copper

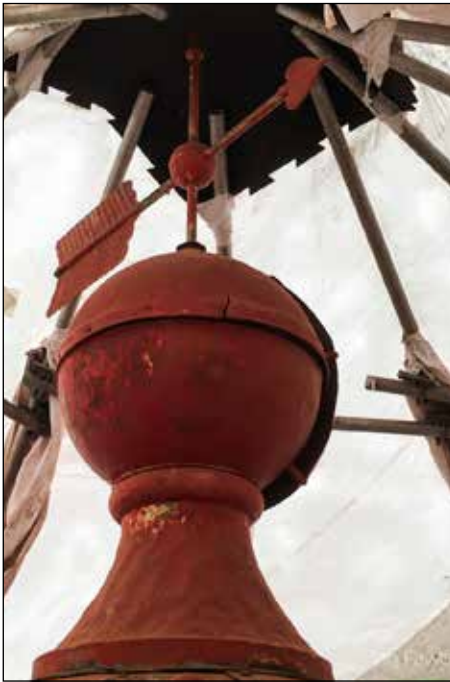
As we were able to access the top of the dome, we were able to assess the condition of the weather vane at the peak. It was severely corroded, to the point that it no longer was able to rotate or serve any function as a weather vane. The outer panels were cracked and deteriorating, and it was suspected that this was another point of water ingress, causing leakage into the interior of the lantern room.

Image 60 (top left): weather vane showing corrosion and damage,

The second option was chosen. Unfortunately, the corrosion was so extensive at its base that it could not be removed without cutting it out, meaning that a new mounting collar would need to be fabricated.

The weather vane was cut from the tower, the external panels removed and taken to Foggy Mountain Forge for restoration and refabrication. Once cleaned, restored and repainted, it was reassembled. In its complete form, it was too large to be taken back to the top of the tower through the internal hatches, so it had to be raised with a winch up the outside of the tower, once the sheathing had been removed, but prior to the scaffolding being removed. It was reconnected with the new mounting collar, and now functions properly as a weather vane. (See following photographs).

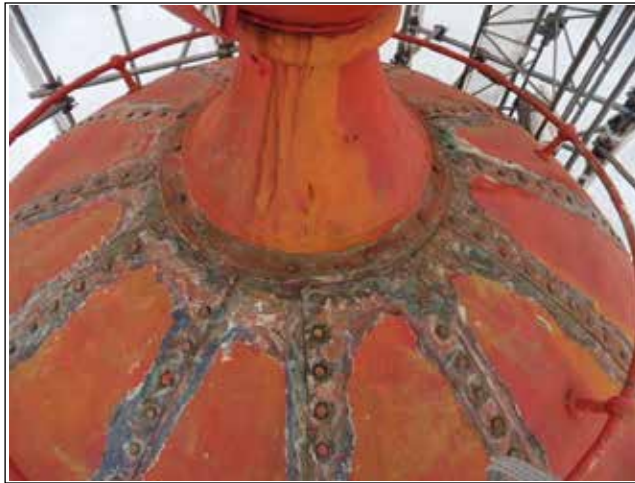
Image 61 (top right): weather vane mount, showing corroded mounting ring

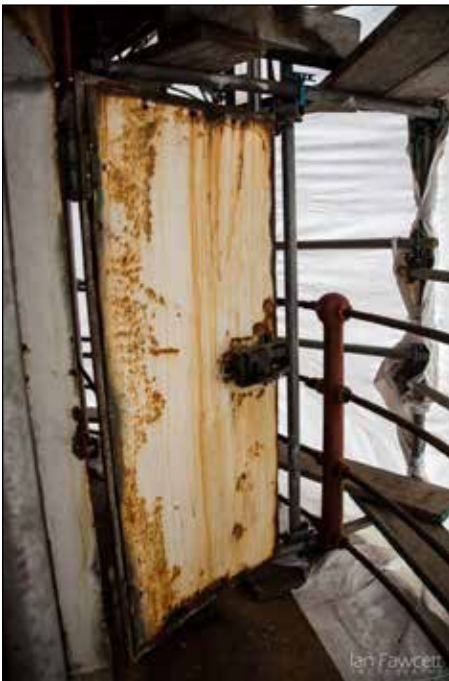
The exterior door leading from the lantern room to the exterior walkway was severely corroded, on both the interior and exterior sides. Blacksmith Marty Gilbertson (Foggy Mountain Forge) was consulted about how best it could be restored and it was recommended that the interior cast steel panel be removed and replaced, as it was too corroded to be repaired. It was felt that the exterior could be cleaned and restored.

Image 65 (left): lantern room door interior, showing corrosion and beginning of separation of top panel from the rest of the door

The door was removed from its hinges and taken to Foggy Mountain Forge, where the work was completed (except the painting). The restored door was rehung in the lantern room, but it was found not to close properly, due to the rigidity of the new plate that had been attached. This required that it be removed again, returned to the forge where it could be slightly bent, and then rehung. It now fit relatively well, and it was decided to install some weather stripping around the edges to provide a better seal. The door was then painted along with the rest of the lantern room. (See following photographs).

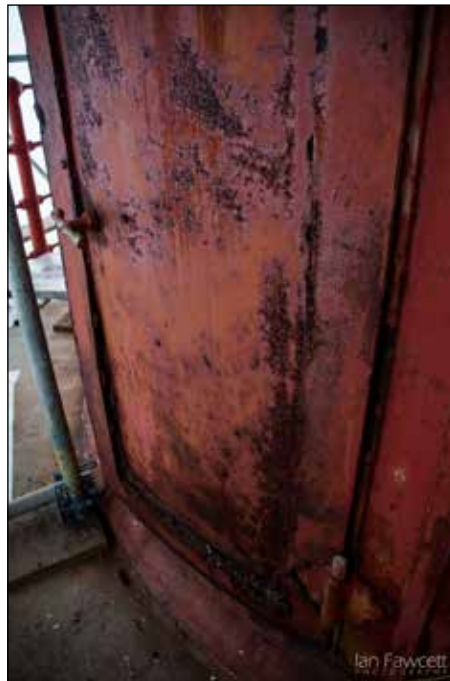
Image 66 (centre): lantern room door exterior, showing extensive corrosion

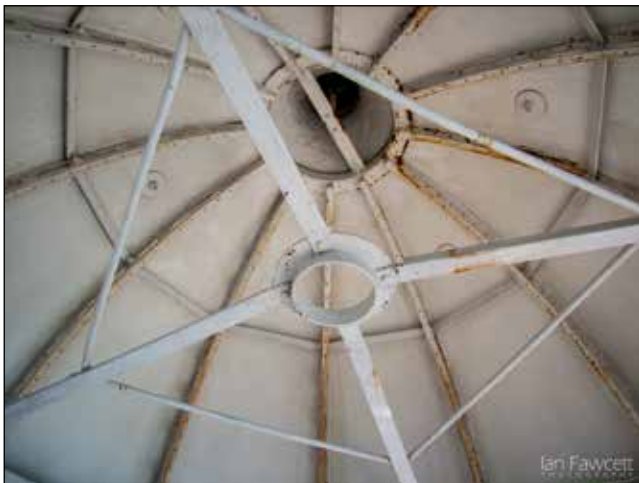
The interior walls, floor, catwalk, dome roof and structural beams were in relatively good shape, although they were stained in some areas (especially the roof) by water leakage. It was decided that the existing paint did not need to be removed, but could be simply ground down for painting preparation. Applications of paint were made as required (two or three coats in some critical areas – primer/sealer and topcoat). Colours were as indicated above (white walls, roof, beams and mullions, deck grey catwalk and floor).

Image 74 and 75 (top row): original condition of lantern room interior, showing some corrosion

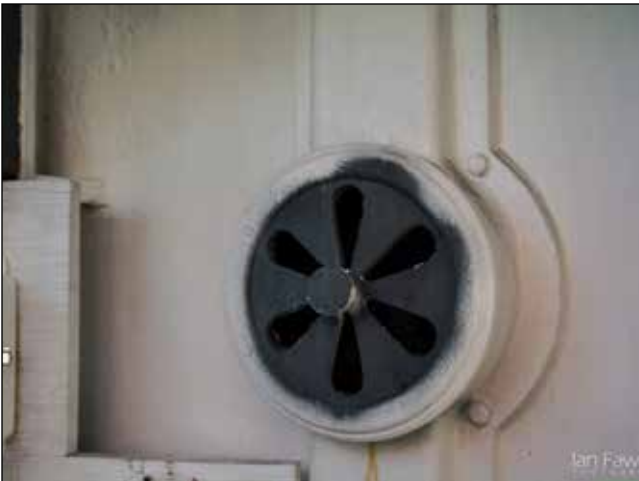
There are twenty small round vents located in the lower walls of the lantern room. They open and close by means of a central, hand-turned screw handle. All of these vents had several layers of paint, some had signs of corrosion, and all were non-functional (i.e. they could not be opened or closed as they were “painted shut”). It was decided to remove the vents, to be taken to the foundry (Smith Bros.) where they could be sandblasted to remove the existing paint and corrosion. Upon completion, it was discovered that these vents were made of brass, which was not previously known. Also, it was determined that many of the central screw-handles were no longer functional, nor were many of the mounting screws. Accordingly, replica parts were fabricated at the foundry.

Image 78 (top left) and 75 (previous page): show vents in original condition

Rather than repaint the (now) cleaned and functional vents, it was decided to leave them as bare brass, and reinstall them in that condition, both to improve their functionality and to show them more clearly in the lantern room. (See following photographs).

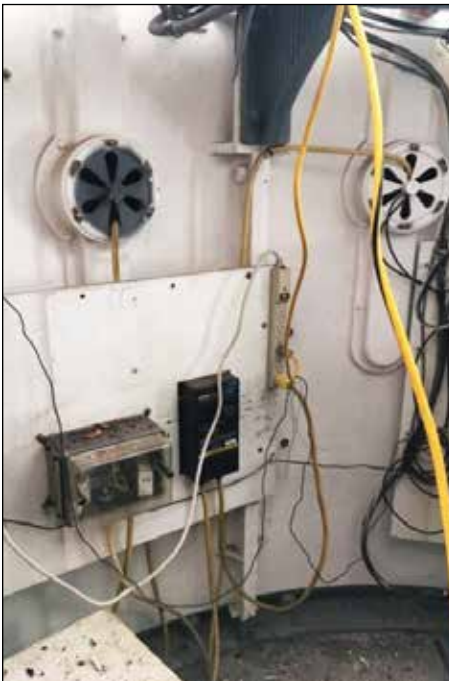
The main challenge was that the cables feeding the exterior equipment had been fed casually through the vents, rendering them non-functional. As the vents were being restored, an alternate route for these cables was necessary. An option was considered of routing the cables through a more-recently-added aluminum frame window, rather than cutting into the historic fabric of the lantern room itself, however, after consultation with an electrician, it was determined that this option would not be possible (to provide a secure exit) without further damage to the lantern room wall. Accordingly it was decided to re-route these cables through a small hole drilled adjacent to one of the vents to provide proper, sealed and permanent access to the exterior (the same as had been done previously for other cables). (See following photographs).

Images 81, 82 and 83: previous arrangement of cables in lantern room, going through vents to the exterior, and loose cables exiting vent on the outside

The solar panels were removed, and the beacon and weather station were connected to the site's power supply (the batteries were retained as backup). Extraneous cables were removed, and the remaining cables were replaced, relocated and restrung in an orderly fashion, as necessary, to enable easier movement within and around the lantern room.

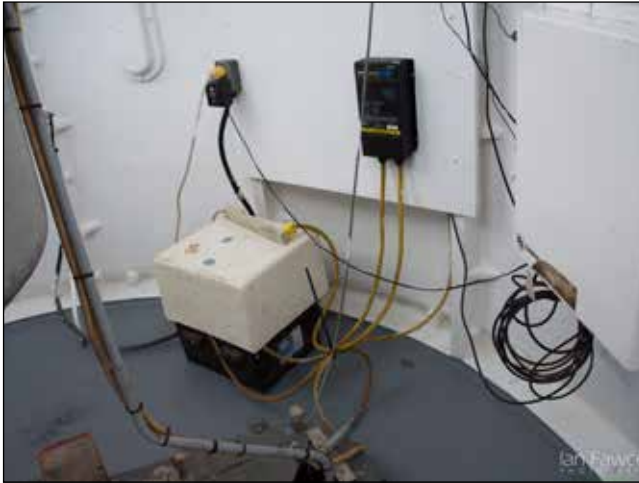
Image 84(left): showing cleanup of cables in lantern room

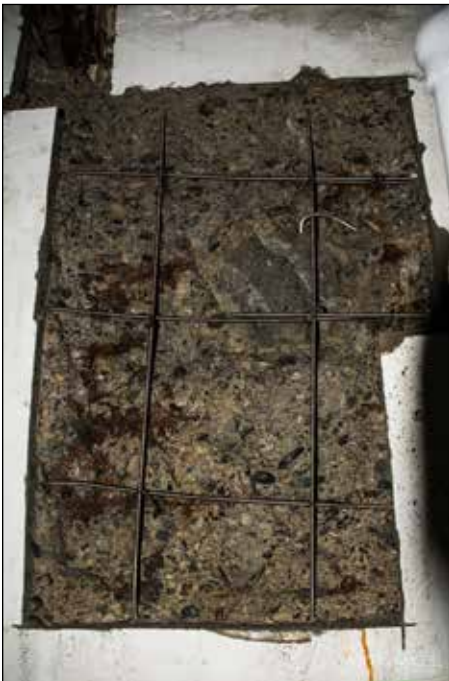
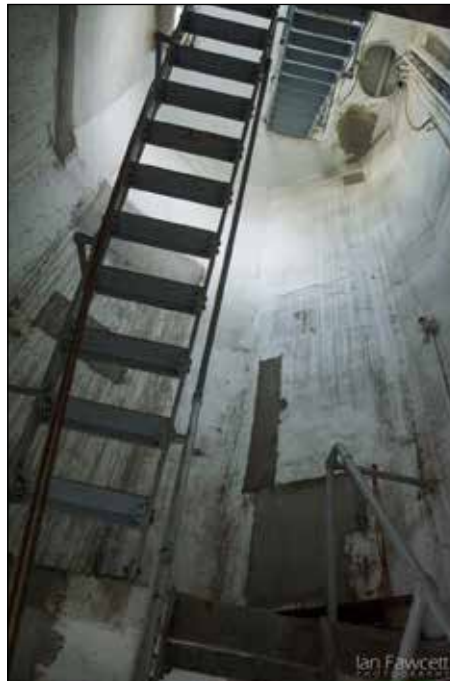
Images 86(top left) and 87 (centre left): show repair target areas chipped out with stainless steel reinforcing bar (grid) inserted

Among the first steps taken was an inch-by-inch examination of the entire interior of the tower walls, to identify every weak spot and mark it for repair. It was decided that repairs would be done by using hand-held equipment to chip away and deteriorated concrete. This was the safest and most “heritage-sensitive” approach, removing as much deteriorated material as necessary, but as little as possible. The exposed areas were then refilled with a pre-mixed, polymerized cement mortar compound (Planitop-X). In larger exposed, the mortar was reinforced with a re-bar grid. (See following photographs).

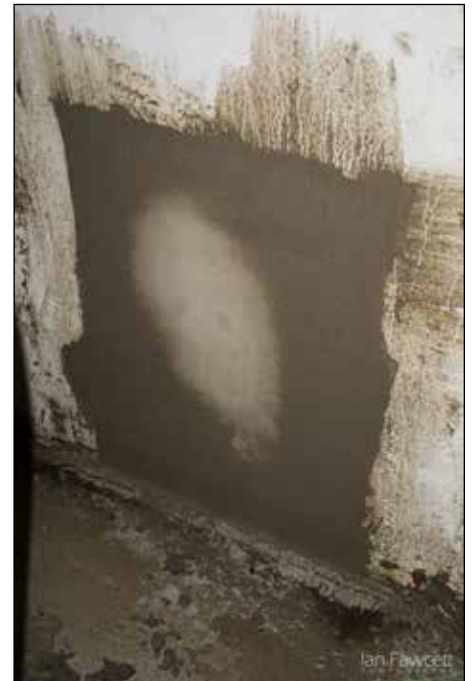
Image 88 (centre centre): showing repaired areas (dark patches) along one side of the mid section in the tower

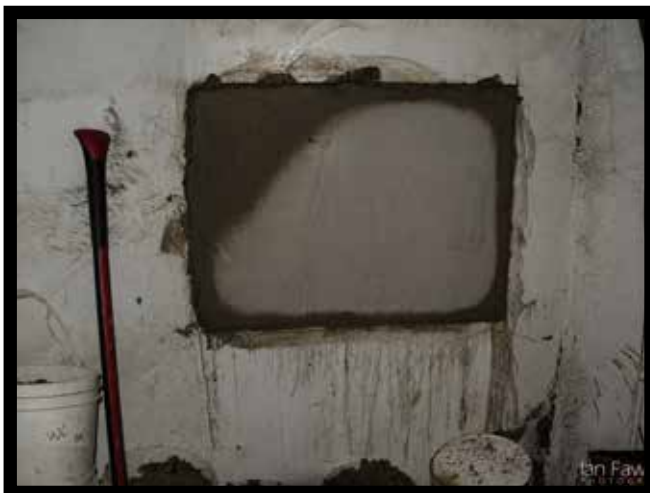
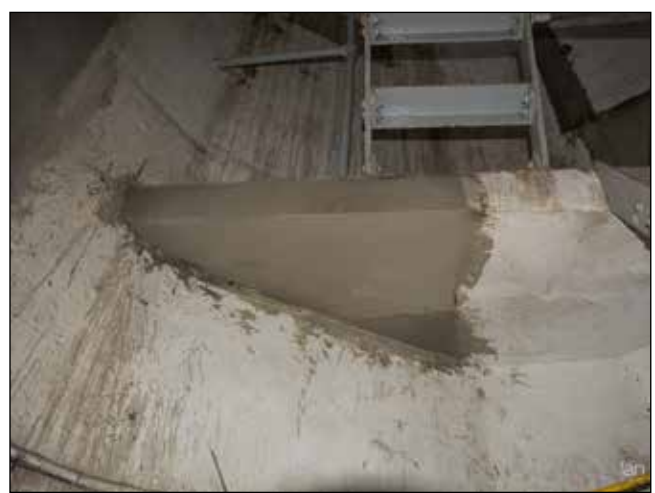
Images 89 (centre right), 90 and 91 (bottom row): showing finished patch areas in various states of drying

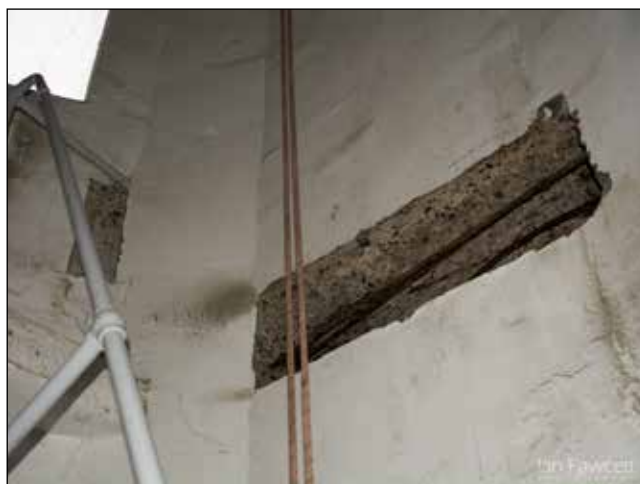
Images 92 and 93 (top row): showing stained and flaking condition of paint in tower interior

Outside of the repaired areas, the concrete and paint cover was in relatively good condition. It was not known, however, whether the existing paint was lead based. Accordingly, following consultations, it was determined that it was better (particularly from an environmental perspective) not to remove the paint but to leave it in place and cover it. There were also some areas of corrosion (not significant) on the metal staircases. This corrosion was removed by hand-grinding.

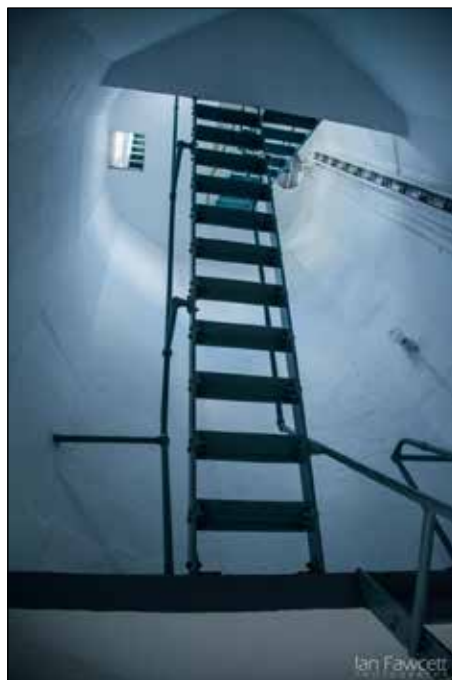
Images 94 and 95 (bottom row): tower interior following patching and repainting

The same paint materials were used as in the lantern room, with white for the walls, and deck grey for the staircase and floor. Two coats were applied, a base coat/sealer and a top coat. (See following photographs).

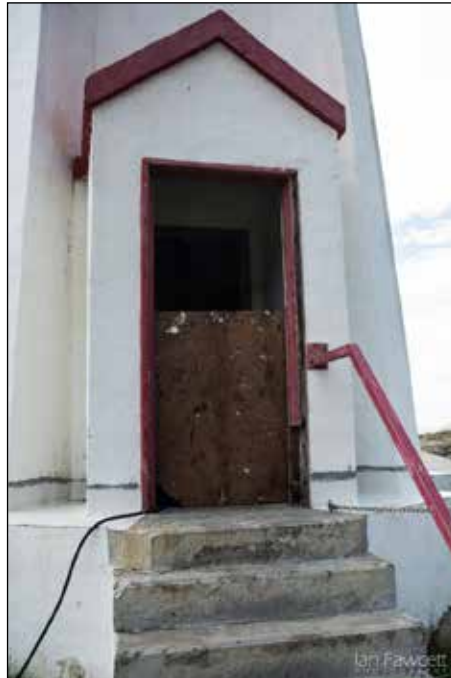
The wooden door jamb surrounding the exterior opening of the portico at the base of the tower had partially rotted (mostly on the west side), due to the effects of weather over the years. The rotted wood was cut out and replaced with a new wood of the same dimensions, then painted along with the remainder of the exterior of the tower. (See following photographs).

Images 96 and 97: showing rotting door jamb (right side of door), and restored door jamb after painting

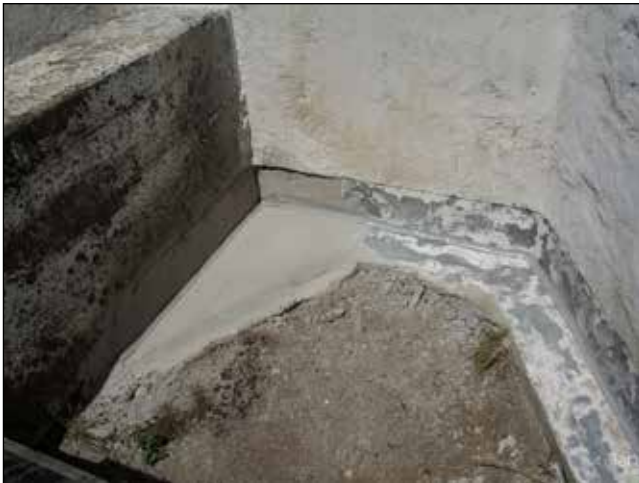
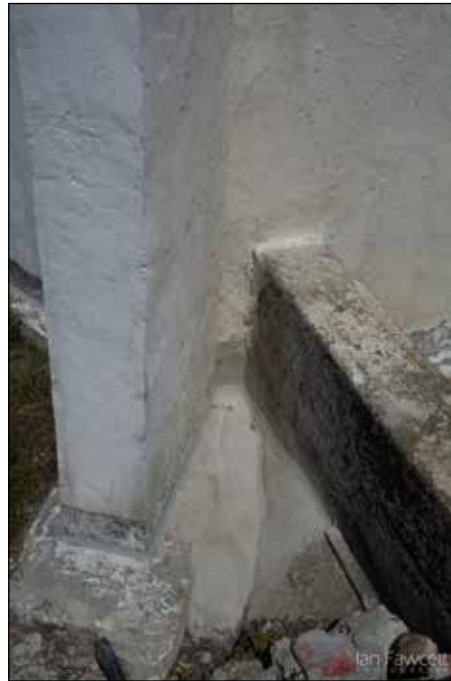
For some time, water had been pooling in the base of the tower following rain. It was believed initially that this was a result of the leaking in the lantern room, as water was periodically seen on the interior walls (which were also stained from the leaking). However, following the restoration of the lantern room, with no further evidence of leaking at that location, water was still found to be pooling at the base of the tower. This caused us to investigate further, and it was determined that due to the topography of the bedrock immediately to the south (water-side) of the tower, rainwater was collecting in the spaces between the buttresses on that side of the tower, and seeping through the concrete base into the tower.

Images 98 and 99 (top row): excavation to address leakage issue - compound patches are points of water ingress

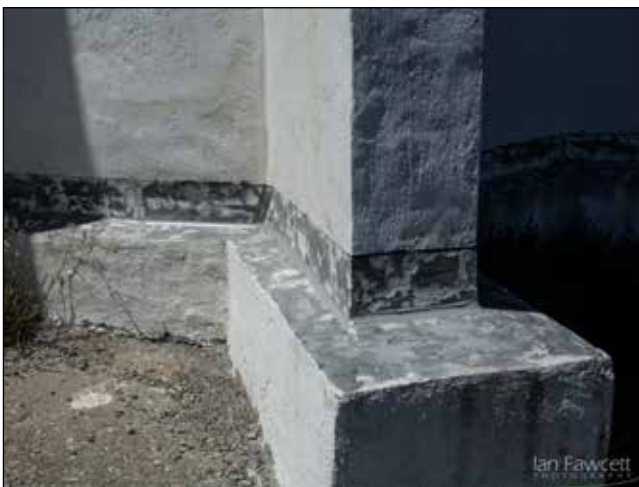
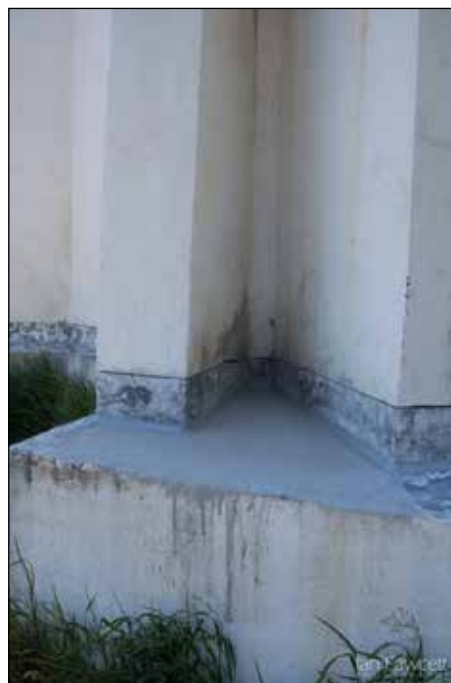
Images 100 and 101 (bottom row): water-proofing around base to protect from splash-back

As part of the landscaping work to be completed in the coming months, the disturbed area will be regraded to the extent possible, and refilled with gravel to improve drainage and help reduce water retention. It is likely, however, that due to the bedrock topography (which slopes toward the tower base) that this may be an ongoing issue, and should be monitored regularly.

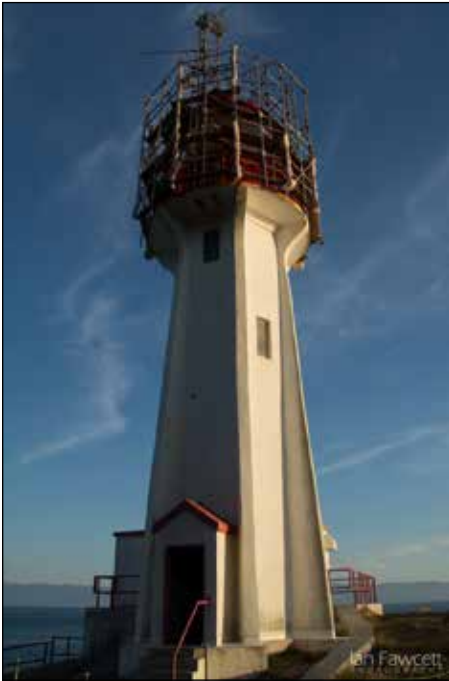
Other than the staining from the rust running down from the lantern room, there were only a few small spots that could be found (by visible examination) where the paint had chipped or blistered, nor could any significant areas be seen of concrete degradation. It was felt that only minor repair work would be needed, and that the existing paint did not need to be removed, but could remain as a substantive base.

Image 102 (top left): pre-painting condition, showing staining at top, along buttresses and around base

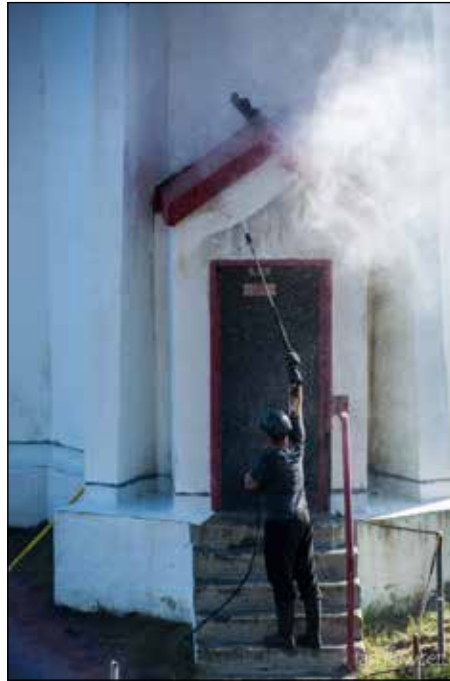
Image 103 (top centre): power washing prior to paint application

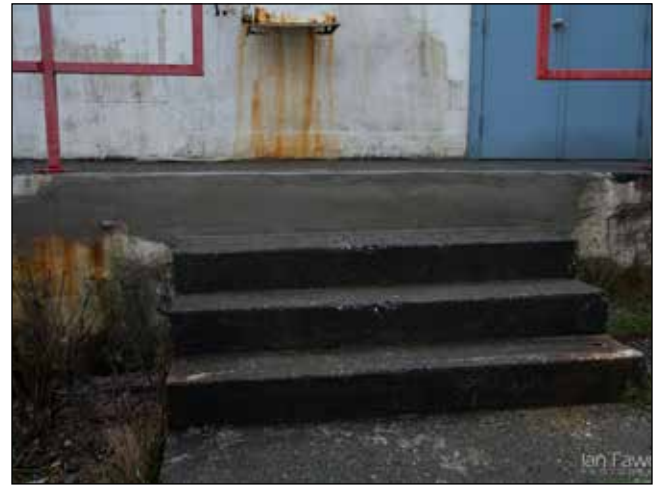
One area of specific concern was the stairs leading up to the engine room. These stairs were cracked and required repair. However, and more significantly the three stairs were not at consistent heights, as would normally be expected for stairs, but each was a different height. The height of the top step was greater than would normally be found in any functional staircase. This was felt to be a safety hazard (although minor).

Images 108, 109 (previous page and 110 (top left): showing cracking and crumbling in concrete base and stairs of engine room

Consideration was given to removing and rebuilding the stairs. However this would be an interference with one of the character defining elements of the site (the intact structural form), and so was rejected as an option. Consideration was also given to adjusting the heights of the stairs by adding a thin layer of concrete (of varying depth) over the existing stairs, to even out the heights of the steps. Again, this was considered to be changing (albeit only slightly) the character of the structure, and so it was decided simply to repair the cracks and leave the heights of the steps as they were.

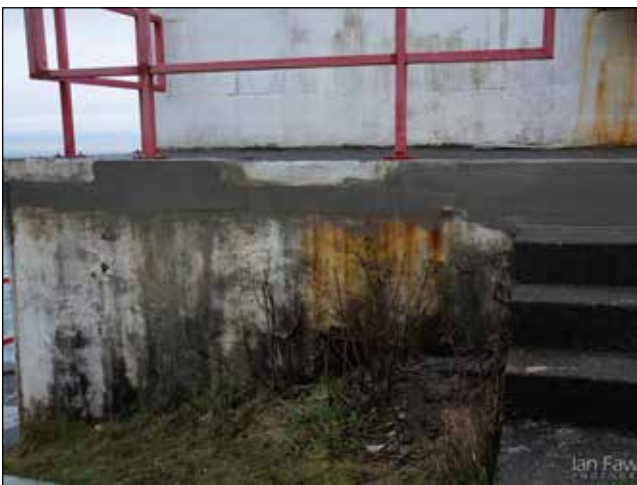
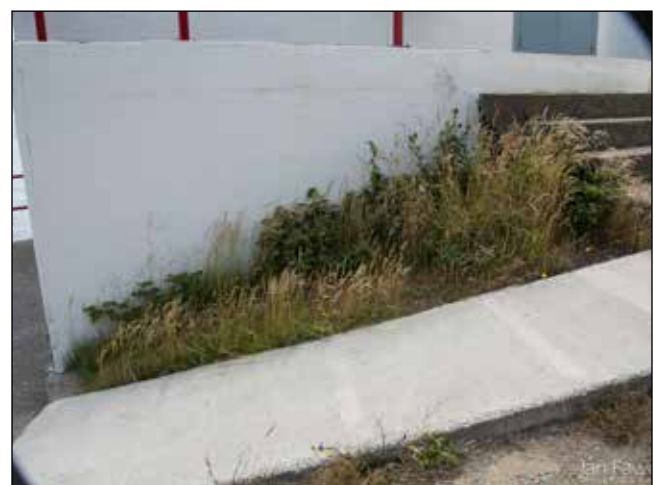
Image 111 (top right), 112 and 113 (bottom row): concrete surface restored

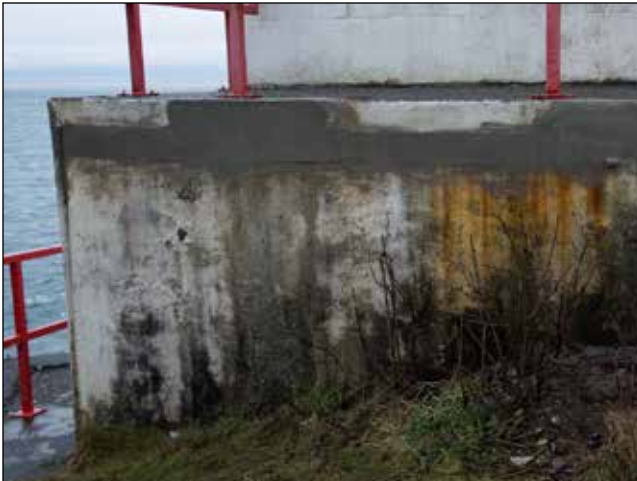
The exterior paint on the engine room was significantly weathered, patchy and flaking in a number of areas. It was scraped for preparation, and the old rusted conduit removed. A base coat and two top coats of paint were applied (same specifications as for the tower). The walls were painted white, and the roof was painted red, and the door painted deck grey.

Images 114, 115 (top row) and 116 (centre left): show paint condition on walls, roof and base

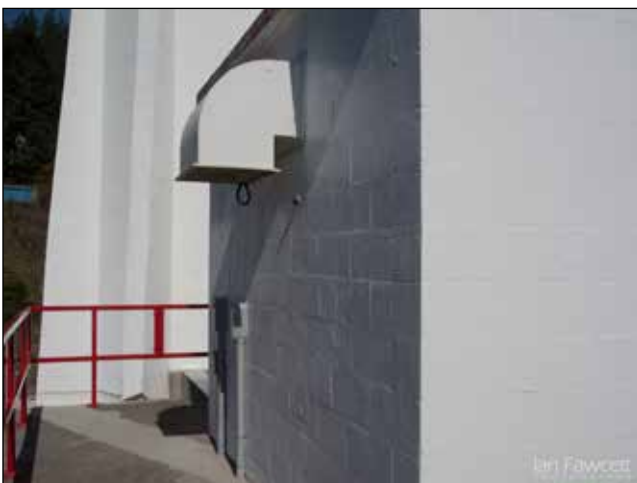
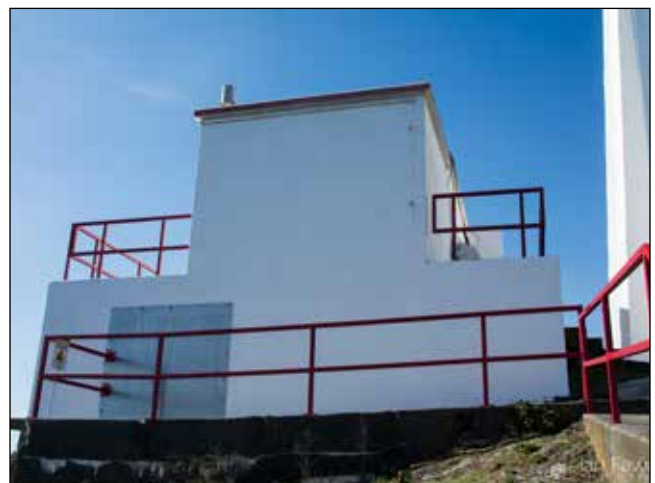
Images 118 and 119 (bottom row): show finished painting

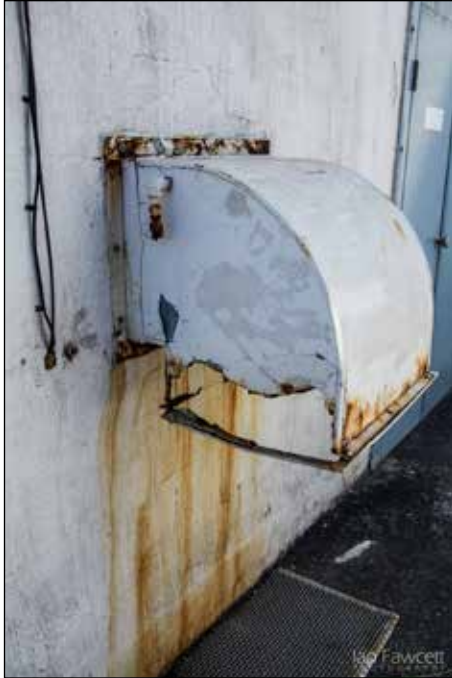
An air vent hood attached to the north wall of the engine room was seriously corroded, with parts of it completely eaten away. Also the metal brackets that attach it to the wall opening were seriously corroded, beyond repair. The vent hood was removed and taken to Foggy Mountain Forge, where a replica hood and mounting brackets were manufactured. The hood new hood was installed, and then painted. (See following photographs).

Images 120 (left): vent hood showing extensive corrosion damage

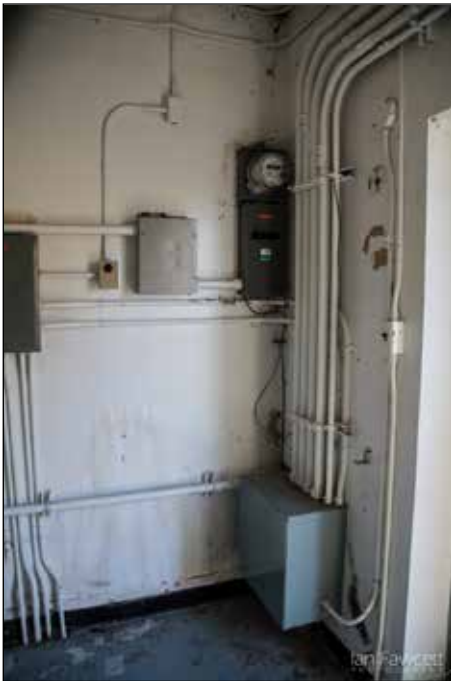
The interior walls, ceiling and floor were all showing wear, but not severe in most places. The main issue was the presence of black mould at several locations on the walls of both the main and back rooms. This was noted to have grown considerably in the past year, and is attributed to the lack of heat in the building during the past number of years. Especially in winter, the interior of the building is cold and damp. The damp had also caused the paper surface of the wallboard to wrinkle in some locations in the main room.

Images 122 (top left) and 123 (bottom left):: showing condition of interior walls and floor - note mould in corner and wrinkling along bottom

With respect to the wallboard, it was determined that the damage was restricted to the surface, and could be repaired with sanding and re-sealing, rather than removing and replacing the wallboard. Accordingly the walls were sanded, and a coat of sealer applied, followed by primer and a topcoat.

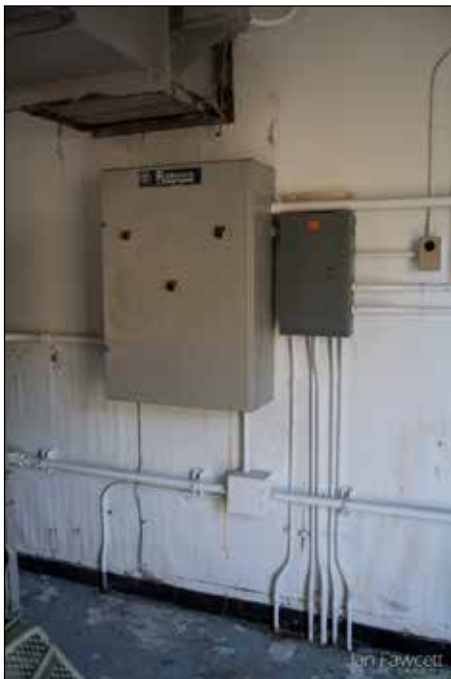
Image 124 (top right):: back (small) room painting completed

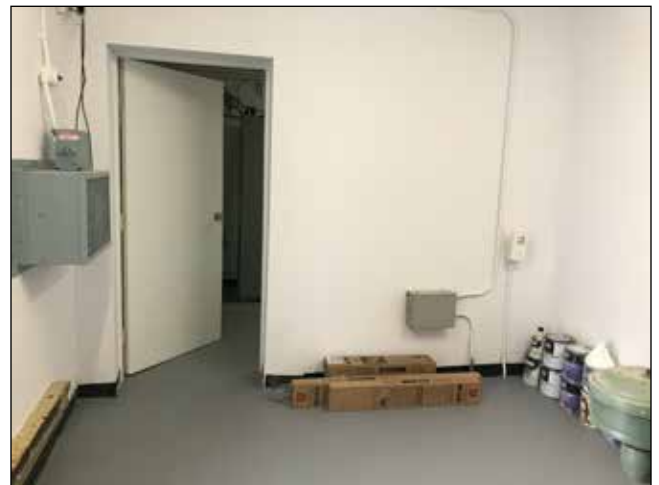
Image 125 (centre right): main room painting completed, showing interior of vent hood

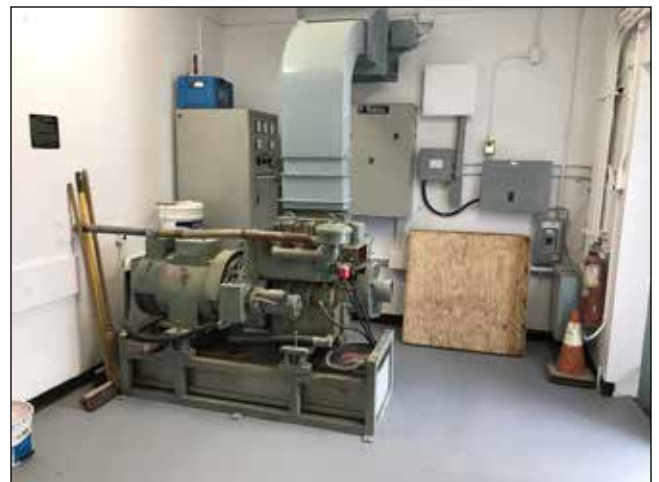
Image 126 (bottom right): main room painting completed, also showing venting painted

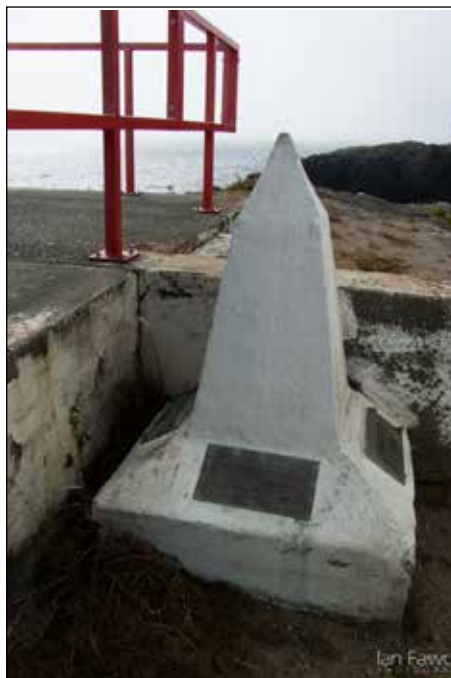
Image127 (left): reference marker prior to painting

The reference marker, which is located between the engine room and the tower, marks the location of the Canada-Us boundary. Its condition was good but getting worn, so it was decided to give it a coat of paint for protection. (See following photographs).

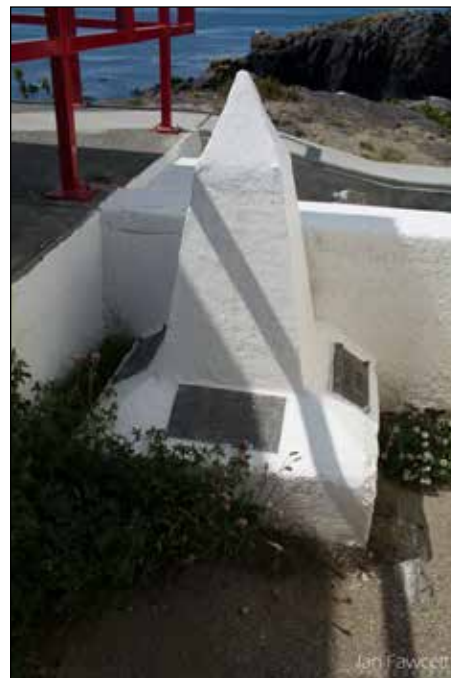
Image 128 (right): reference marker after painting

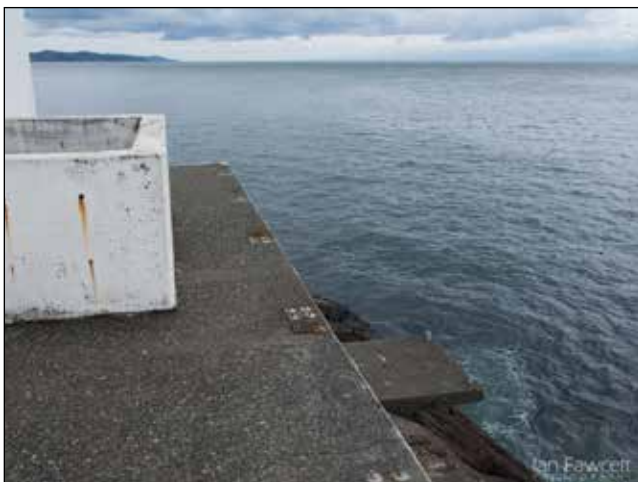
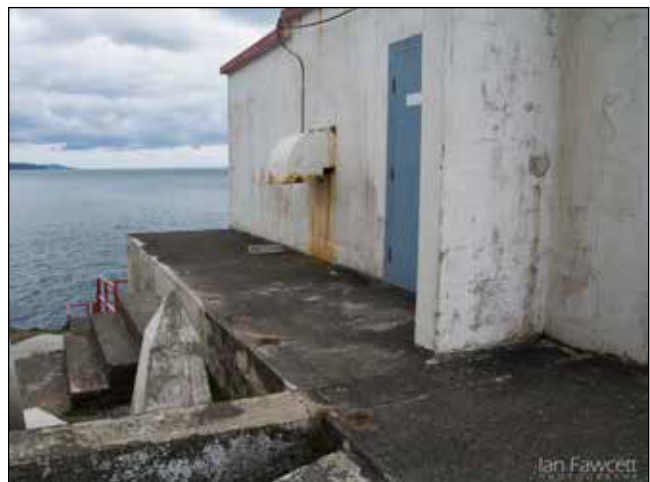
Images 129 and 130: rails removed for powder coating

The safety railings around the engine room platform, and stretching down to and around the lookout platform had previously been powder-coated. Accordingly, the rails were removed from the concrete and taken to the paint shop (Victoria Powder Coating) where they were sandblasted and re-coated. They were then replaced in the same positions from which they were removed (the rails were anchored to the concrete by a metal base (cemented in) with attached bolts.

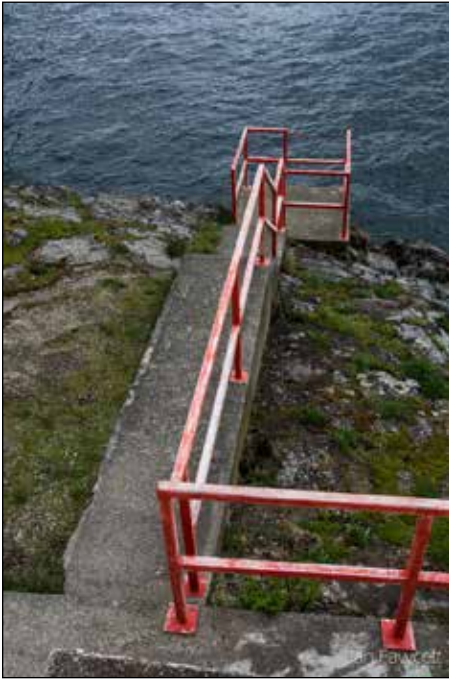
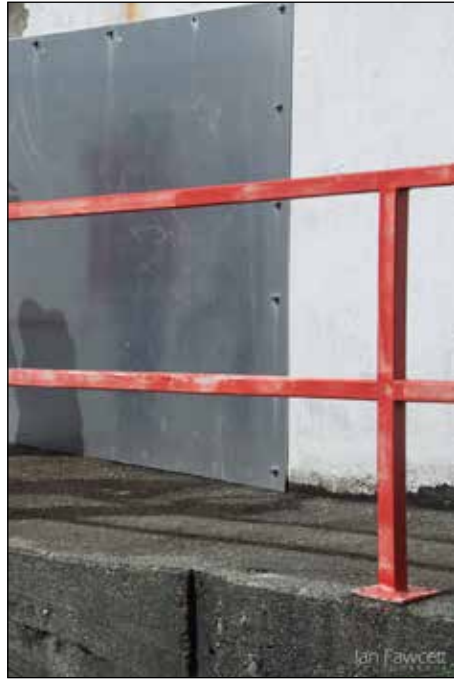
Images 131 and 132 (top left and centre): condition of remaining rails

The railings running down to and around the lookout platform, however, could not be removed without significant damage, as they were cemented in to the concrete pathway/platform. Accordingly, they were cleaned on site, through hand-grinding, and then given a coat of primer/sealer and two top coats of Amerlock (red).

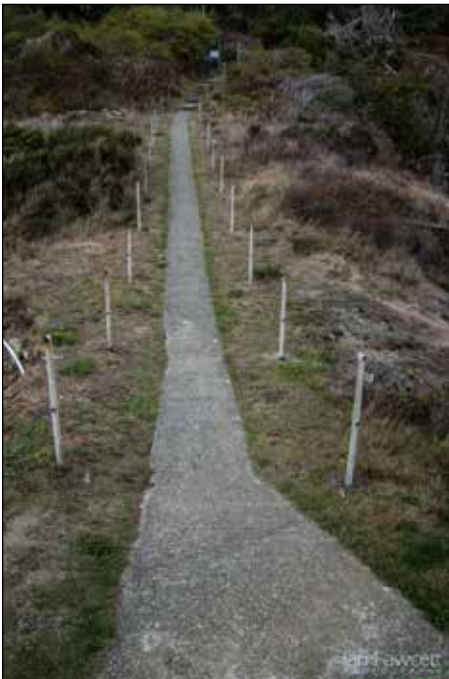
Image 137 (left): pathway and stanchions, in original location and without chain rails
