SHERINGHAM POINT LIGHTHOUSE

RESTORATION
2015 - 2019

Final Report
&
Documentation

Sheringham Point Lighthouse
Preservation Society

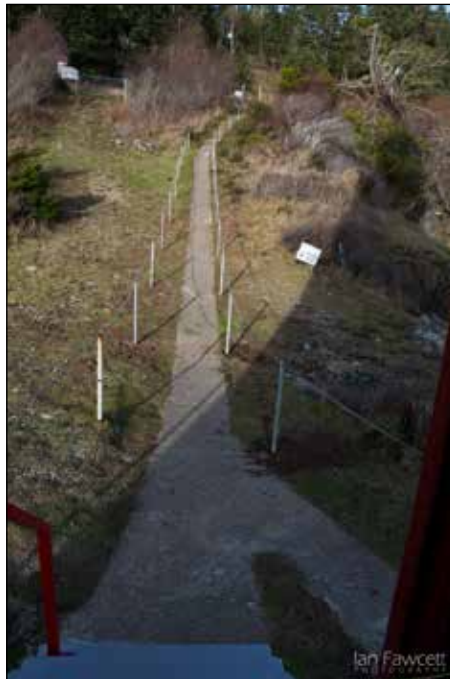
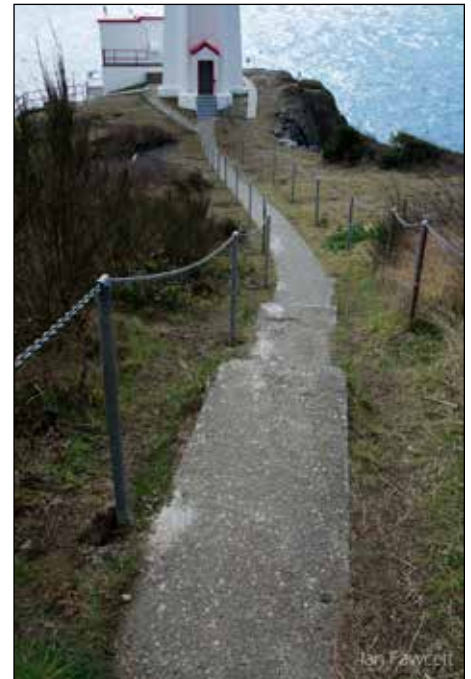
Images 138 and 139 (centre and right): east side stanchions relocated and chain rails added

With the number of seniors (and others with mobility challenges) now using the site, the need for handrails to assist in accessing the lighthouse and (particularly) returning up the relatively steep pathway was critical. It was decided to relocate the stanchions on the east side of the pathway so that they would be within reach of the pathway users.

In addition, four of the required stanchions had been lost over the years, and these were replaced with new stanchions of the same size and design. (See following photographs).

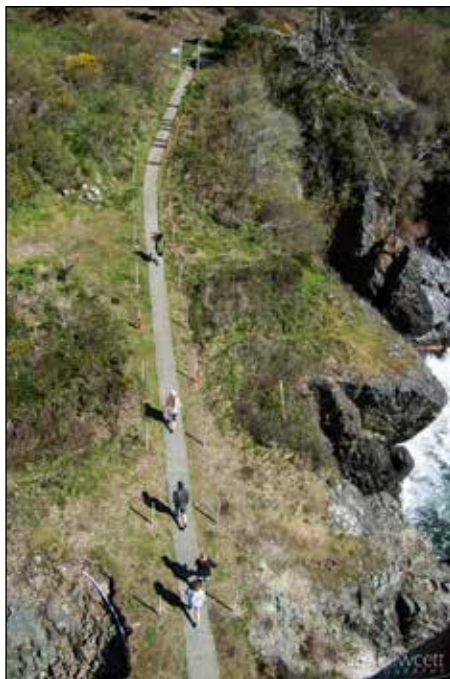
Image 140 (left): heritage pathway across causeway

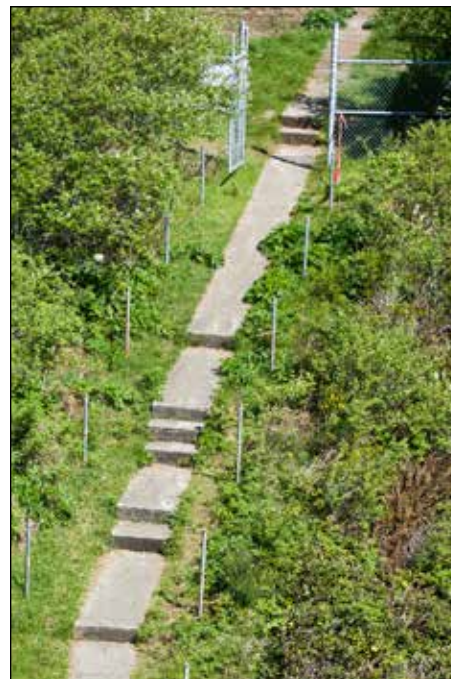
The concrete pathway was constructed in the mid 1960s by lightkeeper Jim Bruton. Accordingly it was deemed to be a significant historical feature, and as such it was decided that no changes should be made to it. There are nine steps, in groups of 1, 2 or 3, along the path, which are mostly non-standard heights. Also one of steps is not at right angles to the rise, but slopes downward at about 70 degrees. All of these steps pose a hazard. However, it was decided to leave the pathway as is (as historical fabric), as it was felt the relocation of the handrail would compensate in large part for the hazard. It is recommended that this continue to be monitored (especially the sloping step), and if necessary to install a small caution sign by the step (located on the adjacent stanchion).

Image 141 (right): showing steps on pathway; unlevel step is 2nd from bottom

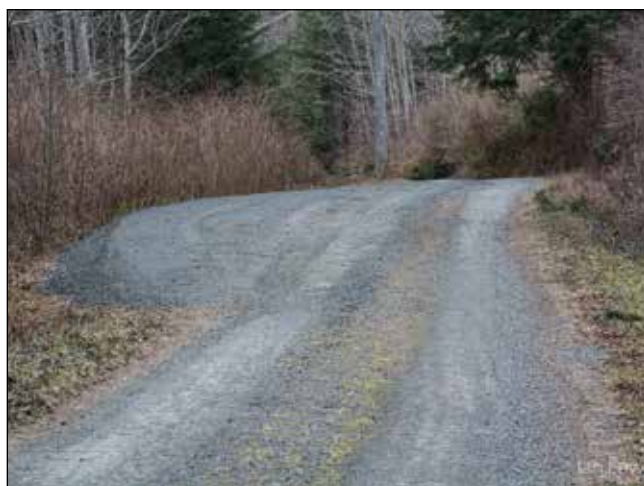
Image 144 (left): original road condition, with vehicle turnout (passing area) under development

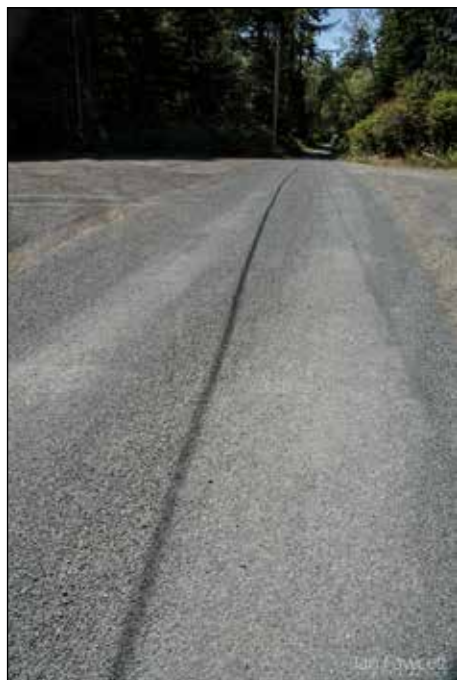
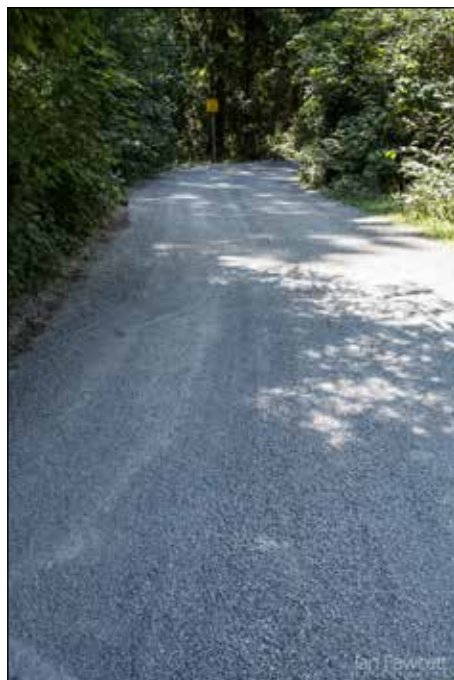
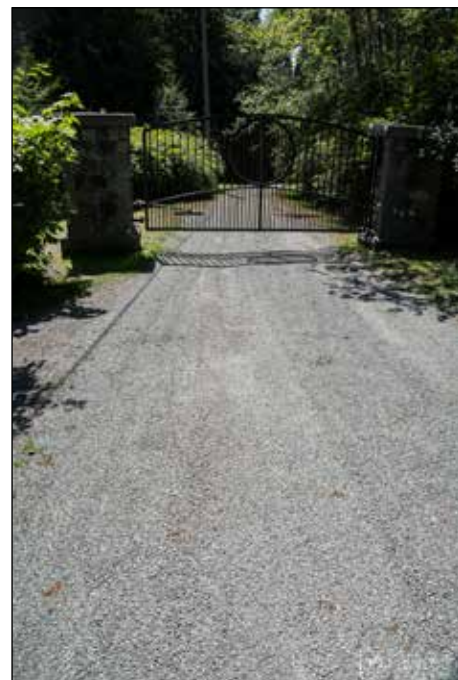
the equipment was otherwise employed in other locations. By then, the condition of the road had deteriorated further, and it was necessary to do additional surface preparation and filling prior to chip sealing. 4M Trucking & Bobcat was unavailable to do the work, and Rumsby Construction was brought in at the last minute to do the preparation. The road was then chip sealed to the extent that the Society's budget would allow, with a single coat extending all the way from Lighthouse Drive to the CRD parking lot (about 600 m), with an additional coat in the more challenging (i.e. steeper and more eroded) areas.

Image 145, 146 and 147 (bottom row): showing road after chip sealing (still in process of settling) at the upper parking area, the hill by the water tower and the gate

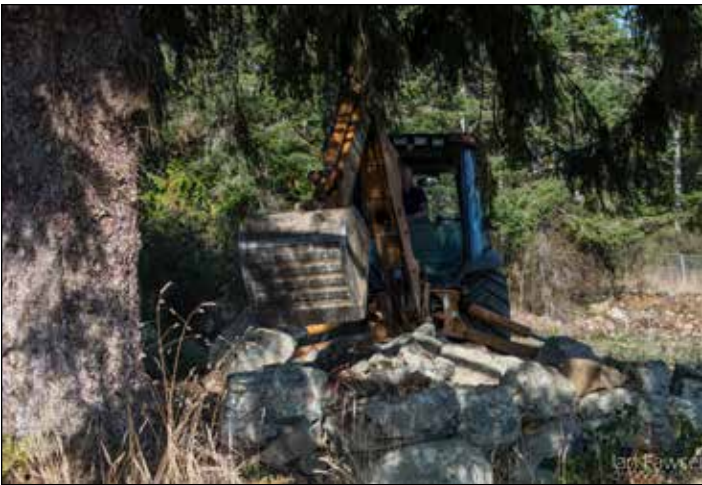
Image 148 (top left): placing boulders to create retaining wall for interpretive area

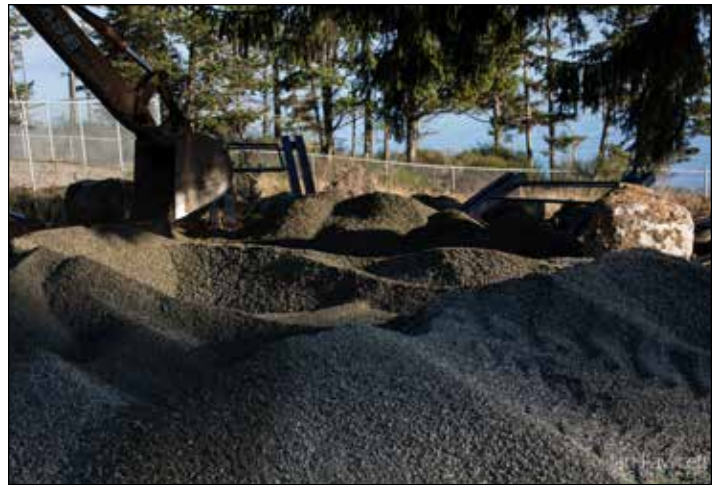
Image 149 (top right): filling and levelling interpretive area
